# Analysis and Solution of Flooding Water Problem for EV Passenger Compartment

Dongfeng Motor Corporation Technical Center, Wuhan, China

Li Zhongkui, Xu Zebin, Shu Peichao. Analysis and Solution of Flooding Water Problem for EV Passenger Compartment. *Automation, Control and Intelligent Systems*. Vol. 6, No. 2, 2018, pp. 20-27. doi: 10.11648/j.acis.20180602.11

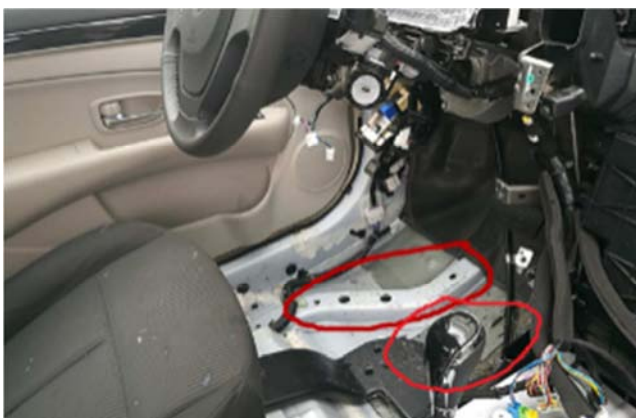
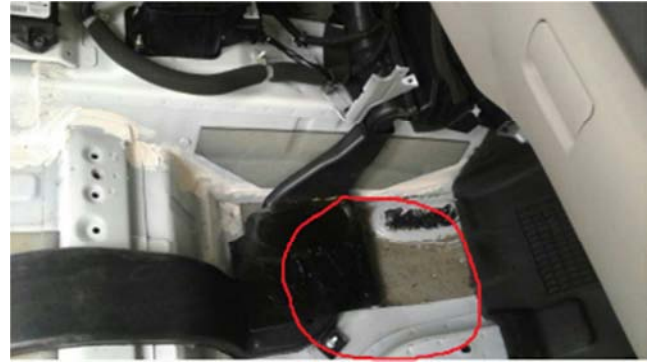
When an electric vehicle was subjected to the local standard for wading, it was found that there were several water inlet points on the passenger cabin floor and front panel. After the test, there was a large amount of water in the low-lying areas of the floor, which was located at the driver's foot place and the co-pilot's foot place, as shown in Figure 2 (a) and Figure 2 (b).

Figure 2. Water spots in the passenger cabin.

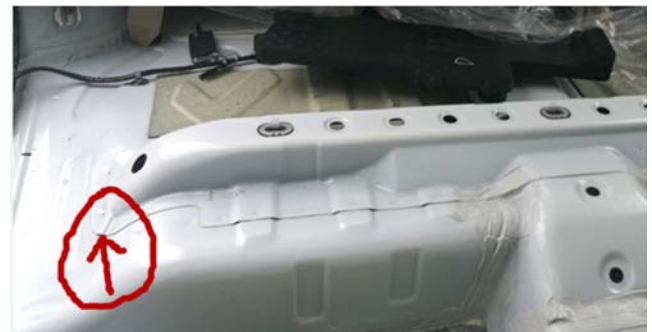
The water inlet point is located at the right end of the beam under the rear seat, as shown in figure 4, there are drops of water running down.

Figure 4. The water inlet at the right side of the middle floor.

(2) To solve the problem of water inlet at the right side of the body floor, the solution is to change the fixed way of the brake pipeline, and change the clamping hole from the clamping hole to the welding screw column, as shown in figure 24. No more clamping holes are designed on the floor.

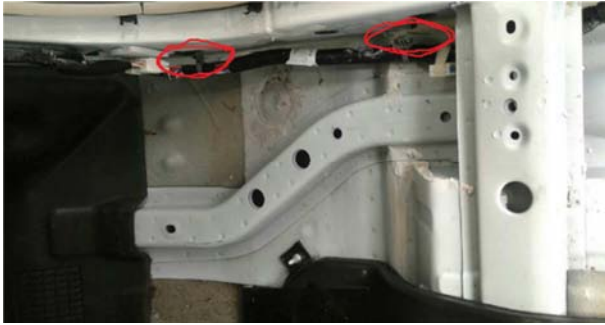
the left and right sides of the body, as shown in Figure 5. Water drops appear at the cable harness buckle installation on the right longitudinal girder of the car body.

**Figure 5.** The water inlet is at the wire harness buckle place, at the right longitudinal beam of the car body.

(3) In order to solve the problem of water inlet at the wire harness buckle on the inner plate of the body longitudinal beam, the solution is to change all the wire harness buckle holes into welded studs, as shown in figure 25.

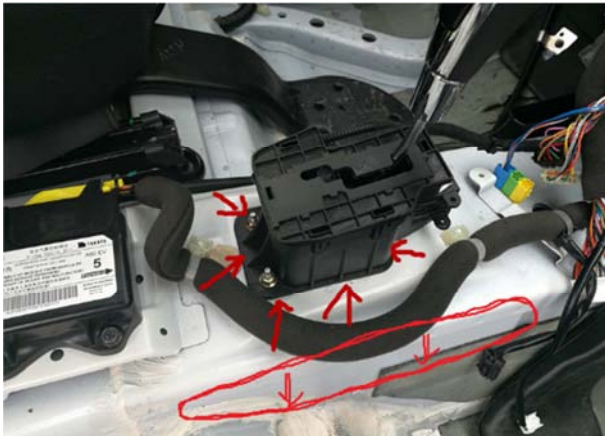
The water inlet point is located around the installation position of the gear shifter, as shown in figure 6. There are water drops flowing out along the periphery of the gear shifter and both sides of the middle channel strengthening plate.

**Figure 6.** Water inlet on position of gear shifter.

(4) To solve the problem of water inlet at the gear shifter installation, the temporary solution is to put a plug in the box with holes on both sides of the box under the gear shifter, as shown in figure 26. Permanent solution is to improve the structure of the box under the gear shifter, or use other types of gear shifter to solve the sealing problem.

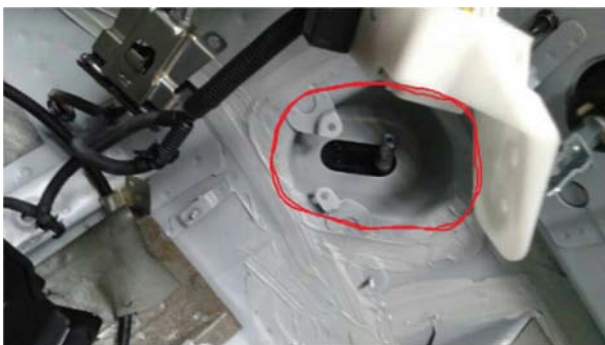
The water inlet point is located at the position of the steering column hole in the cowl panel, as shown in figure 7. There is a large amount of water in the sinking platform of the steering column hole cover.

**Figure 7.** Water inlet at the through-hole position of the steering column.

(5) To solve the problem of water inlet at the through-hole of the steering column on the dash panel, solutions are within the steering column sheath set card hook structure, will cover the collection on car body, as shown in figure 27 and figure 28, through the card hook card tight sheath, keep sheet metal sheath and body moment in the compression state.

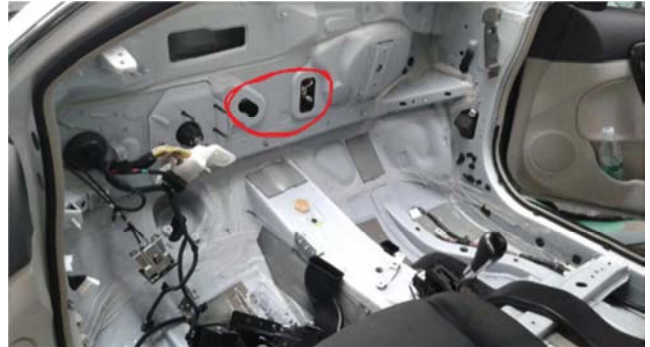
The inlet point is located at the through-hole position of air conditioning pipe on the cowl panel, as shown in figure 8. The sound insulation pad in the cowl panel is removed, and it is also found that the sound insulation pad on the cowl panel corresponding to the air conditioning pipe passing through the hole is wet.

**Figure 8.** Water inlet at the through-hole position of air conditioning pipe.

(6) For the air conditioning pipe passing on the small hole water problem, the solution is to cancel the small sound insulation mat cushions, rubber mat in air conditioning body side, at the same time the air conditioning on ontology local reinforcement plate to plane, to increase the contact area, the maximum possible to stop the water flow into the car, as shown in figure 29.

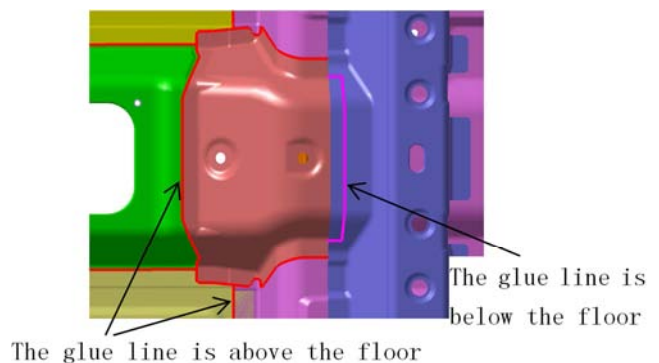
Check the car and found that the original mathematical model defined on coating line, as shown in figure 9, the local not besmear in real vehicle is shown in figure 10, and it is located in the sheet metal pieces of the corner, considering the manufacturing technology level, set aside a large gap, as shown in figure 11. Therefore, if the place is not covered with glue, when the vehicle wanders into the water, there will be a large water flow into the vehicle.

**Figure 9.** The glue line definition of body middle floor.

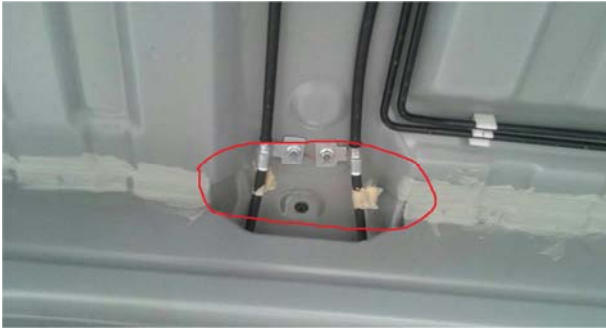
Figure 10. Leaking glue under the floor.

(1) To solve the problem of water inlet the car body middle floor, the temporary solution is to fill up the glue that is leaking. Permanent solution is to improve the local structure of body floor, to cancel the local strengthening structure on the

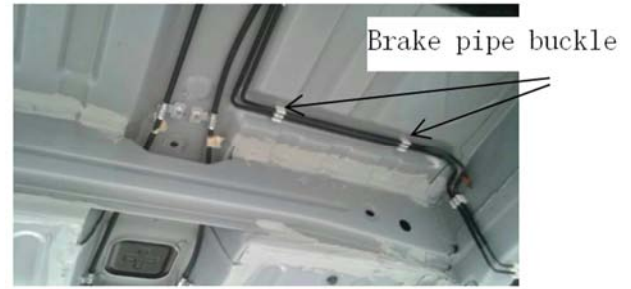
In comparison, there is no water drop on the left side of the floor, and there is water drop on the right side. Check the real car and the number model, and confirm that the water drop is from the installation of the brake pipe lug, as shown in figure 12. It is caused by the failure of complete sealing between the buckle and the hole of the brake tube. Refer to figure 13(a) the buckle structure and figure 13(b) the gap between the buckle and the hole.

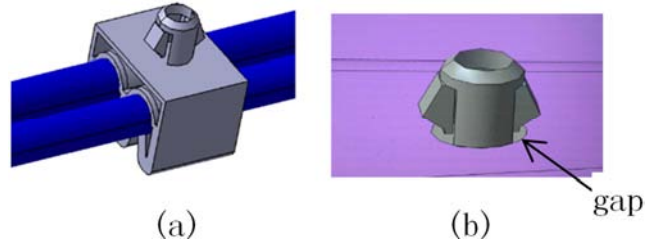
Figure 13. The mounting structure of brake pipe buckle.

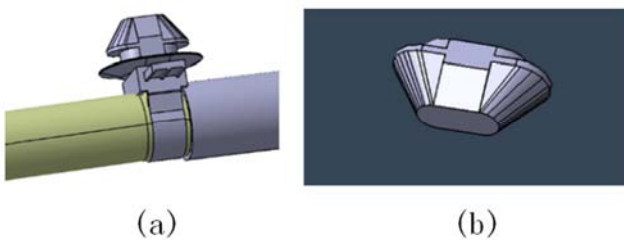
The wire harness buckle is also a common clasp, and it is difficult to ensure complete sealing between the mounting hole and the wire harness buckle, as shown in figure 15.

Figure 15. The mounting structure of wire harness buckle.

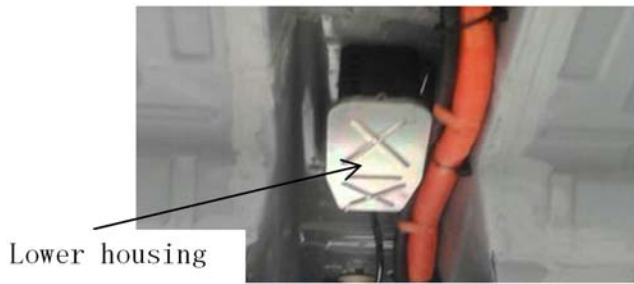
Check the real car. There is a gearshift box below the middle channel, as shown in figure 16. Further inspection of the mathematical model reveals that there are holes on both sides of the under gear shifter box. Refer to figure 17(a) left side of the under gear shifter box and figure 17(b) right side of the under gear shifter box. The hole corresponds to the shaft line of the shift handle, and the seal is not considered in the design. When the vehicle waded into the water, it was easy to get water from the hole into the inside of the gear shifter, which then flowed up and into the car cabin.

Figure 16. The shifter structure below the middle channel.

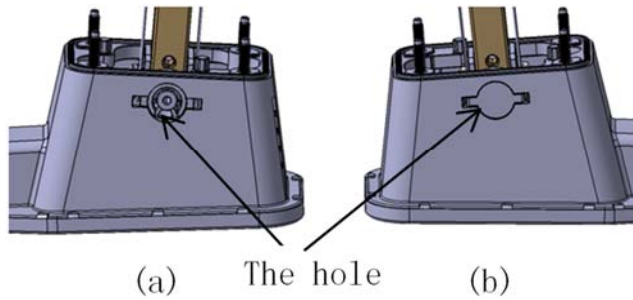
Figure 17. The structure of the lower box on gear shifter.

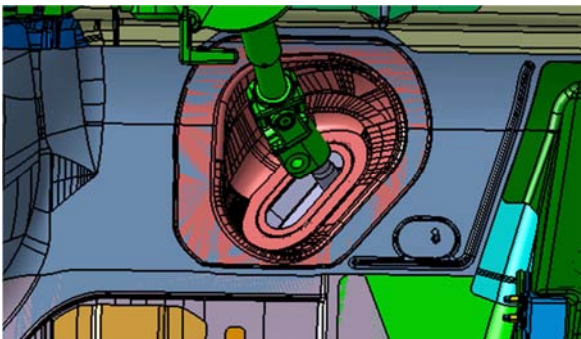
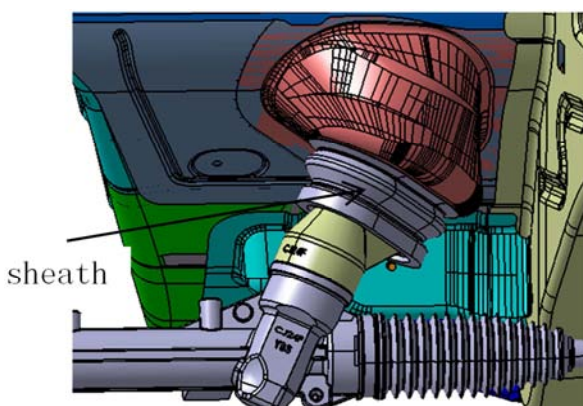
As the steering shaft sleeve is connected to the body only by elastic extrusion, it is easy to be deformed with the wheel beating and steering, resulting in a large amount of water entering the cabin and flowing to the driver's foot place.

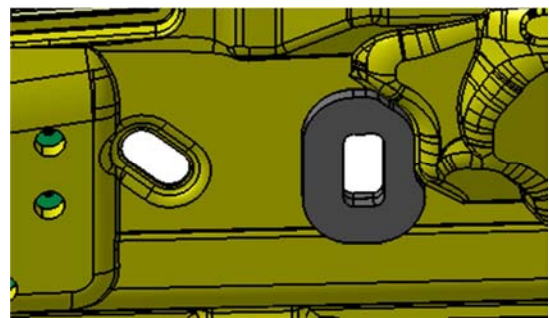
When the air conditioning pipeline passes through the front fender, it does not effectively seal the through-hole, resulting in a small amount of water from the air conditioning pipe passing through the through-hole into the cabin. Figure 20 shows the air conditioning inlet and outlet pipeline structure. Figure 21 shows the hole in the enclosure spacer, only one hole is added with the cushion block, but it is a sponge cushion, which has no waterproof effect.

Figure 21. Front enclosure soundproof pad with through-hole structure.
