Assessment of the Effect of Urban Road Surface Drainage: A Case Study at Ginjo Guduru Kebele of Jimma Town

Getachew Kebede Warati¹, Tamene Adugna Demissie²

¹Jimma University Institute of Technology, Civil engineering department, Jimma, Ethiopia

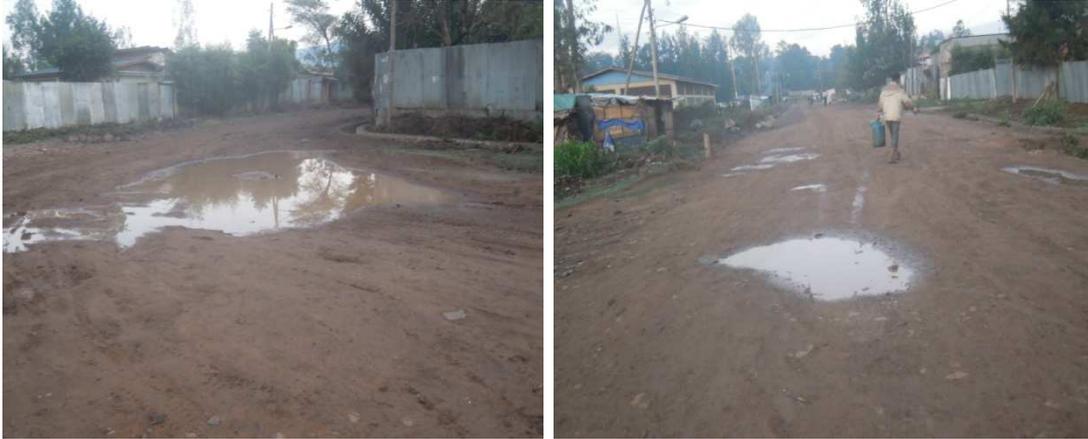
Figure 1. Ponding of water on gravel road in Ginjo Guduru Kebele in front of Jehovah's Witness hall.

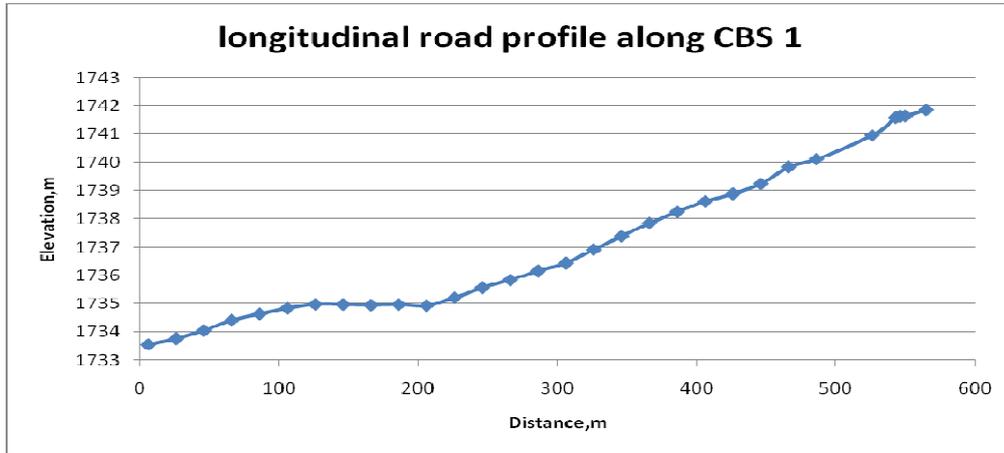
Figure 3. CBS1 road profile.

As it can be seen from table 2, about 15% of the road length have less than 0.5 percent longitudinal slope and

62.97 % of cross fall slope being less than 2.5 %, which is below the required minimum slope for adequate drainage.

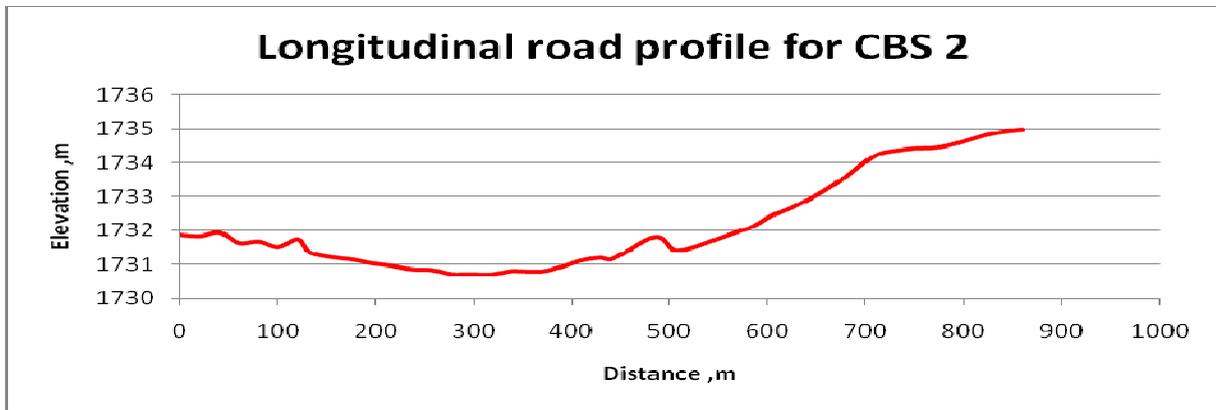
Figure 4. Profile of CBS2 road.

In this part of road segment of 0.9 km, about 48.93 % of the road likely to have less than 0.5 percent longitudinal slope and 51.07 % of the road have less than 2.5 % cross slope. The distribution of the longitudinal as well as cross fall slope between stations of the road is also not uniform and

this retards the safely disposal of water from the road.

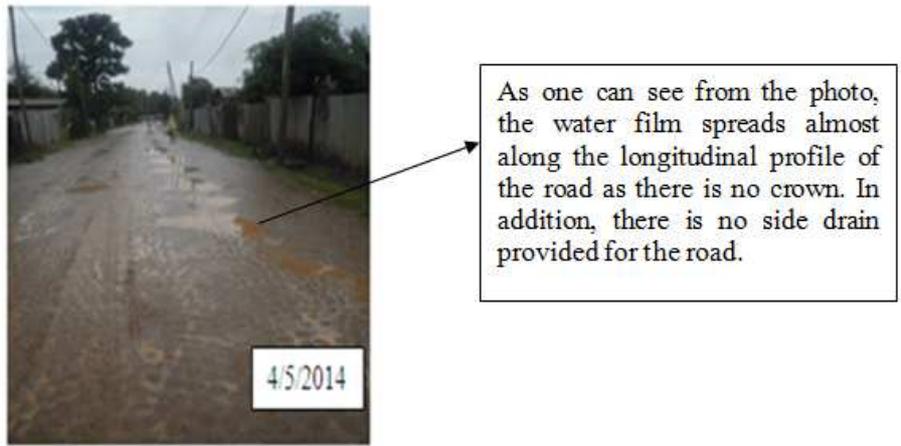
Figure 5. Photo of CBS 3 road.

In this cobble stone road, the cross fall is totally less than 1.0 percent and there is no uniform longitudinal slope as it can be seen from the table which gives favorable condition

for accumulation of water on the road.

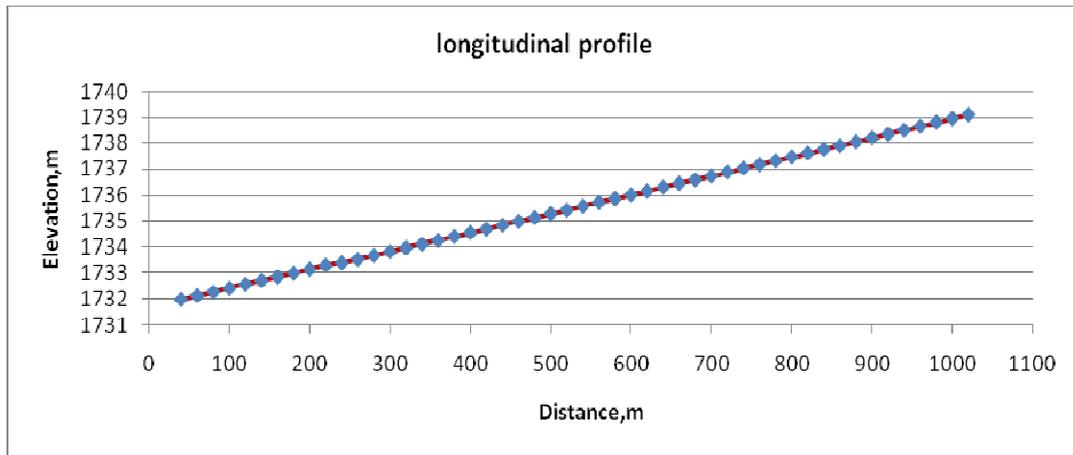
Figure 6. Longitudinal Profile of Asphalt road.

The profile of the asphalt road shown in Figure 6 indicates a uniform longitudinal slope of about 0.86 percent and a cross fall of 3.98 % respectively, which provides rapid removal of storm water from the carriage way of the road to the side drain ditch. The width of shoulder provided for this road ranges from 1.8 m to 2.4 m but the shoulder material is not sealed and subjected to erosion. The erosion of this shoulder is one of the main sources of material that fills the side ditch and results clogging. No manhole provided for the drain ditch of the road to regulate the flow of runoff water.

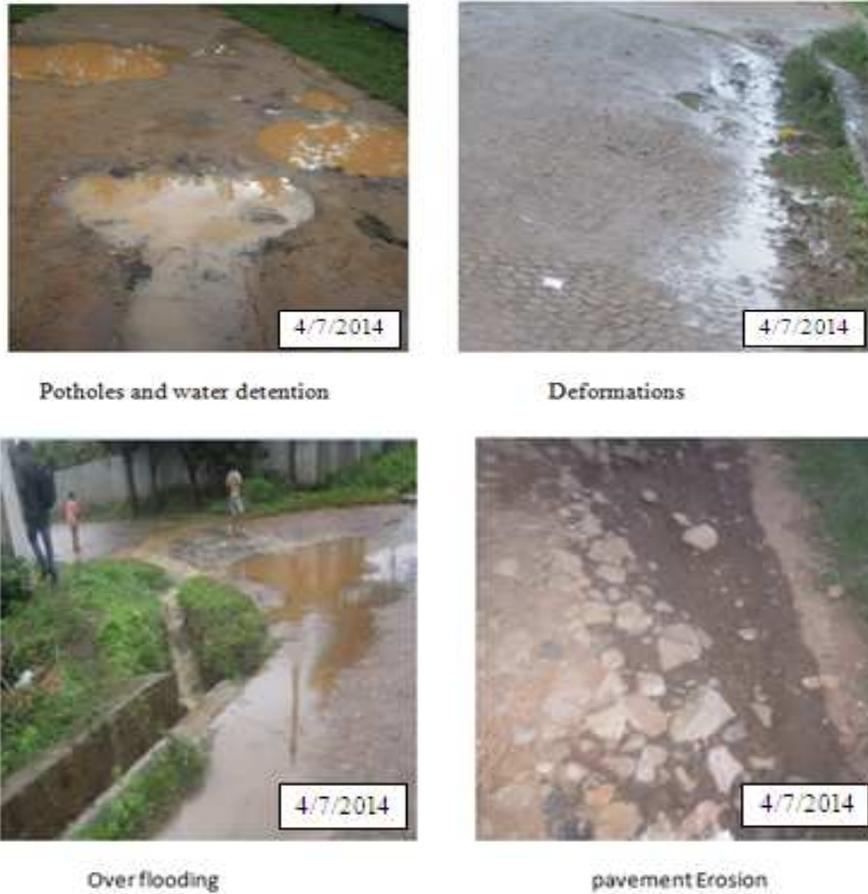
Different types of damages to the roads in the Kebele were observed during the study. These are potholes, washing and

deformations of the road pavements. About 5 cm to 30 cm deformation were observed on cobble stone and gravel road respectively while washing of asphalt road shoulder in the

order 5 to 7 cm also observed due to improper slope. Figure 7 shows different damages occurred to roads in the study area as it was observed in the field investigation.

Figure 7. Photo showing Road damages of the study area.

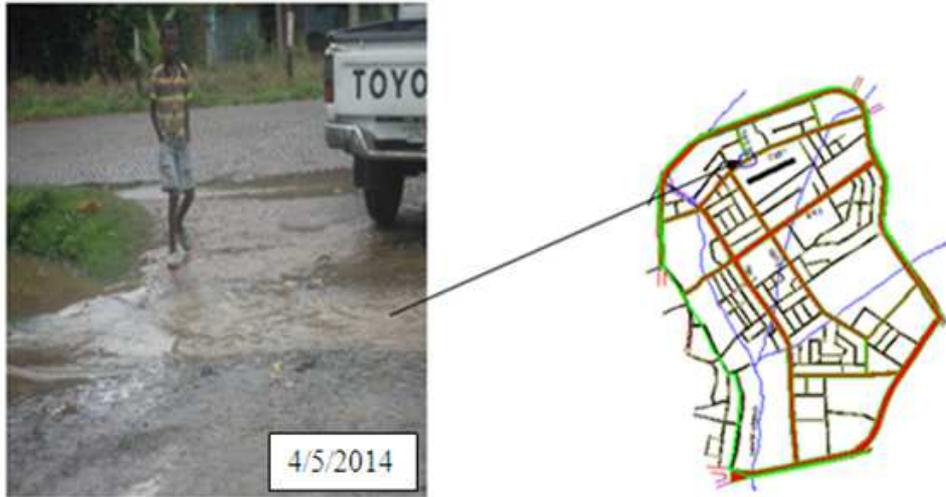
In the junction of CBS1 to CBS3, improper (under- sized) pipe culvert was provided and this create an obstruction to convey the water along the ditch and thus over flooding of water occurs at road crossing junction after every rainfall event. Figure 8 shows flooding due to improper connections or integrations at this location.

Figure 8. Over flooding of water from side drain ditch at road crossing.

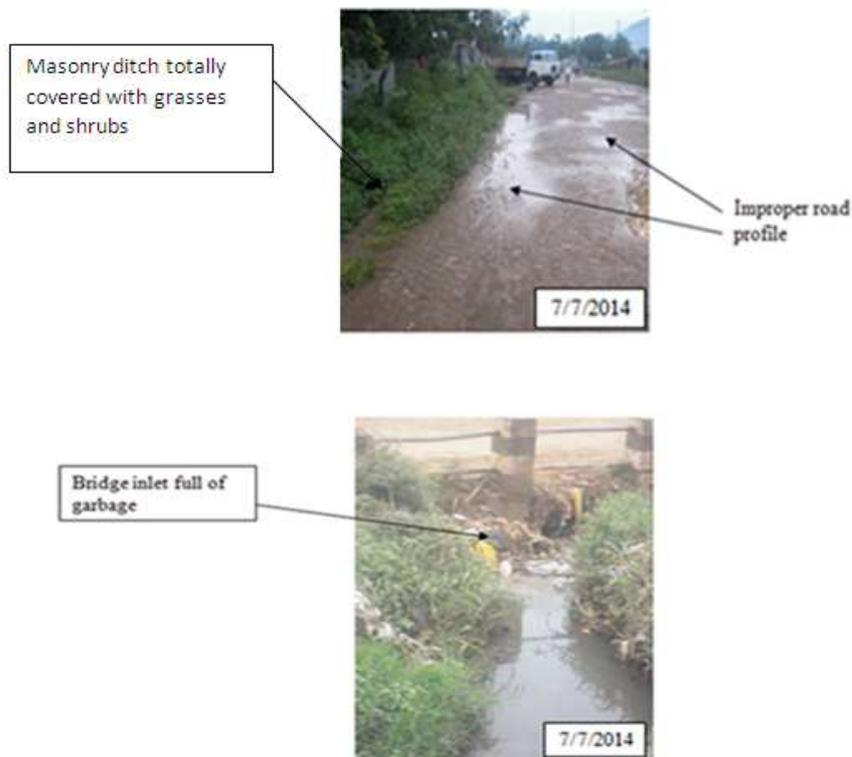
There is no regular maintenance of road and drainage structures as it was investigated during the study. Most of the side drain ditch is full of garbage and sediment at many places which obstruct the normal flow of water in the channel. Some drain ditches are also covered totally with grasses and shrubs and thus not giving the desired function for which it was constructed.

Figure 9. Poor maintenance of drainage ditch, bridge and road surface.

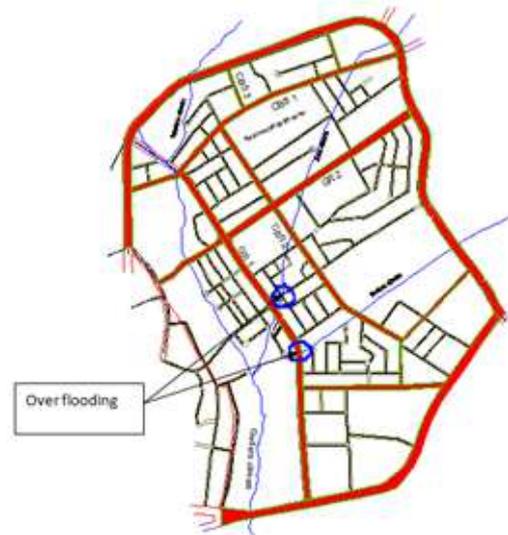
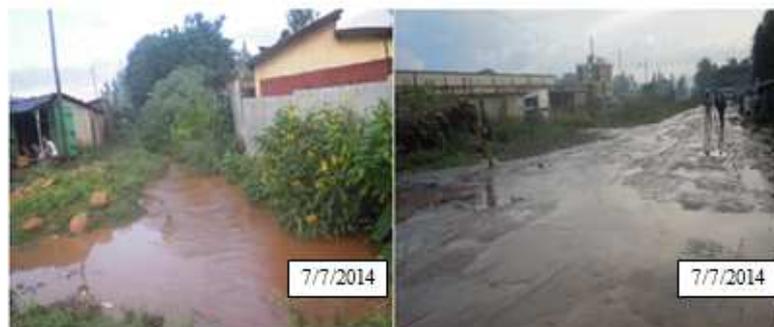
The result of the study shows that though the drainage problem is common in the area, the hazard of the flooding problem is dominant for about 38.6 % of the area and this flooded prone area is located at downstream reach of the Guduru sub-catchment along the streams. Two small bridges over flooded with runoff water in July 2013 due to blockage by debris and the flooding extended to the surrounding residential buildings causing damages or loss to their property. In 2014 rainy season, over flooding of runoff water also occurred to the bridge three times in a season.

Figure 10. Over flooding of road due to bridge and pipe culvert blockage by debris.
