# Supervisor-Field Engineering Approach (S-FEA) of Determining Tyre Failures in the Haul Trucks at Newmont Ahafo Mine

Department of Mining Engineering, University of Mines and Technology, Tarkwa, Ghana

Haul Truck Tyre Life, Supervisor-Field Engineering Approach (S-FEA), Sidewall Cut, Shoulder Cut, Tread Chunking

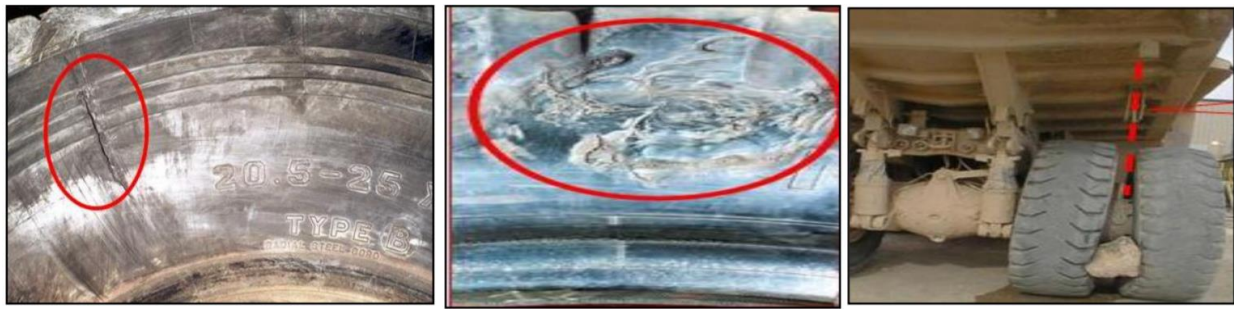
extreme forces and pressures often experienced while driving. This helps to keep the haul truck stable. Though the tyre sidewalls are built to be strong, they can be damaged in several ways, as shown in Figure 6. A literature review was done to identify the major causes of Tyre sidewall cut/damage, which apply to NAM, Ghana. These are: Hitting a kerb (HK); Sharp objects in the work area (SWA); Rocks caught between the dual wheels (RDW); Operator negligence (ON); Under inflation or overloading (UO) and Poor underfoot conditions or water (PUC). Field observations were undertaken from 2010 to 2020 in the Subika and Awonsu pits to identify the most frequent cause of the haul truck tyre's sidewall cut/damage. A total of 42 haul truck tyre sidewall cuts/damage was recorded over the 12 months of study, and the breakdown of the result is present in Figure 7. The field study showed that among the causes of tyre sidewall cut/damage at NAM, paramount among them are poor underfoot conditions or water; sharp objects in the work

area, hitting a kerb and operators' negligence.

**Figure 6.** Haul Truck Tyre Sidewall Cut.

*Figure 22. Critical Questions Process Map for Sidewall Cut.*

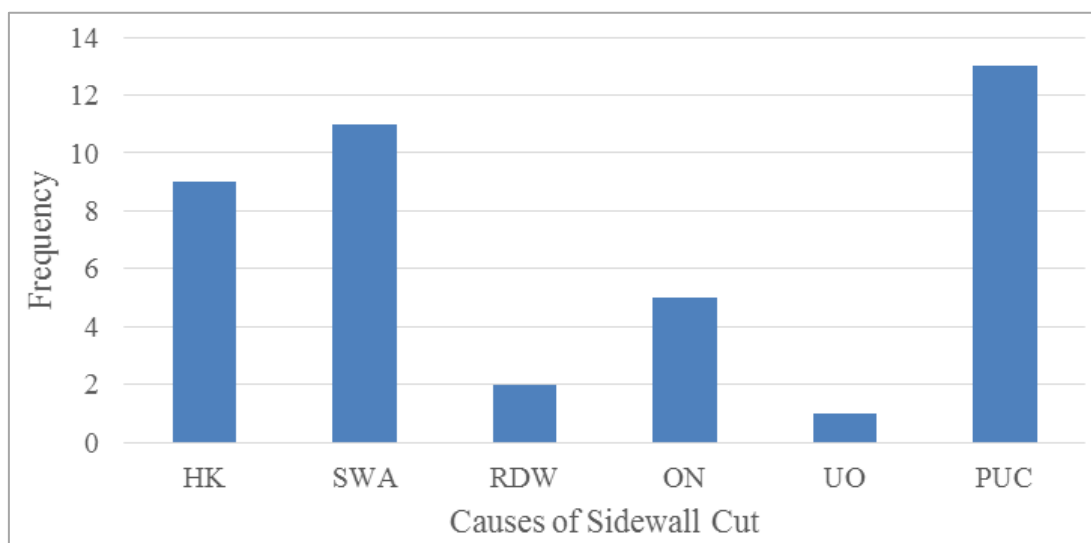
**Figure 7.** Haul Truck Tyre Sidewall Cut.

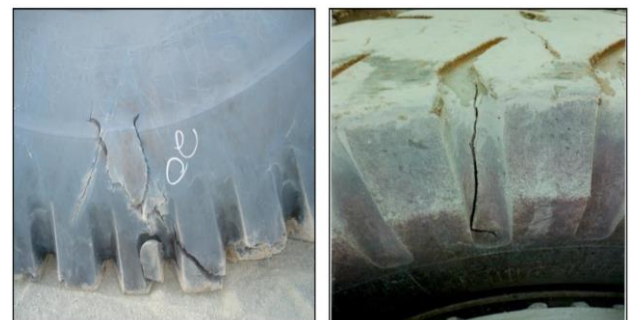
In interviews with field workers, supervisors and superintendents from the mine operation and tyre maintenance departments, the following were identified as contributing factors: Spillage and foreign objects; Course material on the berm/windrow; Poor pit conditions; and aggravated by water. Following the identified causes of shoulder cuts, a field study was conducted in the Subika and Awonsu pits of NAM, Ghana. The data collected recorded 8 cases over the period of 12 months. The breakdown is presented in Figure 9. It was clear that the major causes of premature tyre failure by shoulder cut are aggravations by water and poor pit conditions. Figure 8 below shows a cut in the shoulder area but no casing damage.

**Figure 8.** Haul Truck Tyre Shoulder Cut.

*Figure 23. Process Map for the Shoulder Cut.*

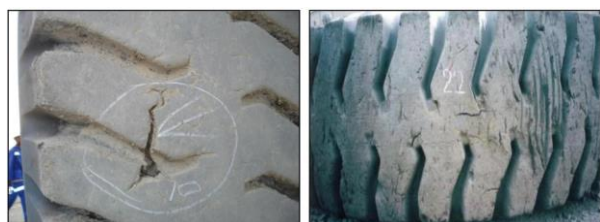
A typical example of a cut in the tread crown but not penetrating the casing is presented in [Figure 10](#). The causative factors of the tread cut include Improper inflation or underfoot conditions (IUC); Aggravated by water (AW); Sharp objects in the work area (SWA); and spinning, skidding or sliding (SSS). The number of cases recorded for the factors that cause tread cut was taken and analysed in [Figure 11](#).

**Figure 10.** Tread Cut.

*Figure 24. Process Map for Tread Cut.*

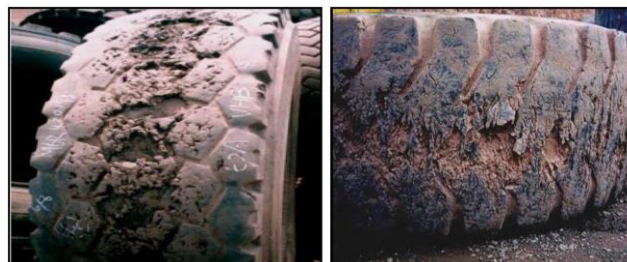
Chunking refers to the phenomenon of missing tyre tread sections, as depicted in [Figure 12](#). It appears the tread has been removed in pieces or ripped away from arbitrary locations on the tyre. In interviews with relevant workforces, contributing factors revealed the following: Improper infla-

tion (II); Underfoot conditions (UC); Excessive speeding (ES); Aggressive braking (AB); Overloading (OL); Mismatched diameters on dual tyre machines (MD); and spinning, skidding or high torque (SSH). Data collected over a period of 12 months, from January 2020 to December 2020, on Haul truck tyre premature failure resulting from tread chunking has been analysed and presented in [Figure 13](#).

**Figure 12.** Haul Truck Tyre Tread Chunking.

Figure 25. Process Map for Tread Chunking.

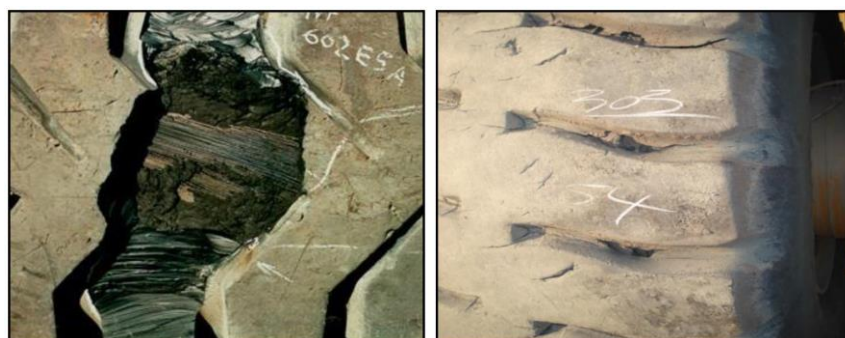
Tyre tread separation is a dangerous condition wherein the tyre's tread separates itself from the casing or body of the tyre. Thus, it is the deformation of the tread area due to the tread band separating from the casing ply, as shown in [Figure 14](#). The contributing factors are excessive heat generation (EHG), exceeding the TKPH for the tyres (ETT), excessive cornering (EC), incorrect inflation or speed (IIS), and overloading (OL). Having identified the major causes of the haul truck tyre failure by separation, fieldwork was done over 12 months – January 2020 to December 2020, to obtain data regarding the most applicable causes of tyre separation at NAM, Ghana. The result obtained has been summarised in [Figure 15](#).

**Figure 14.** Haul Truck Tyre Separation.

Figure 26. Process Map for Separation.

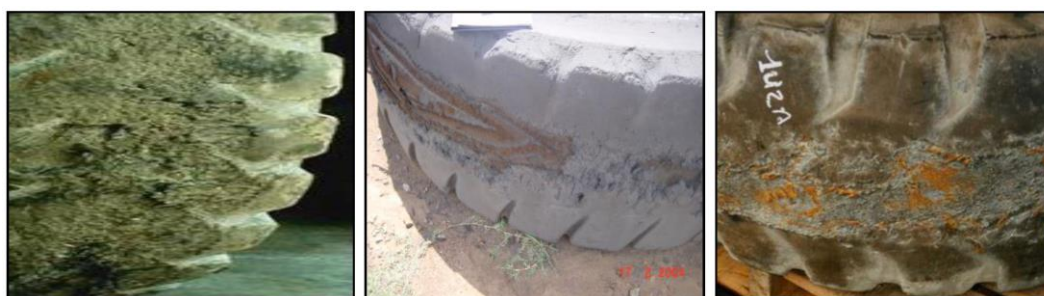
point out that the tyre is worn out. If the tread is worn down to these bars on any part of the tyre, it's worn out, unroad-worthy, and needs to be replaced. An example of tyre worn is presented in Figure 16.

**Figure 16.** Tyre Worn Out.

According to the tyre damage report acquired from the maintenance department, factors contributing to the wear of haul truck tyres include i) improper inflation or overloading, ii) unfavourable operating conditions such as water or undulations, iii) defects in repairs, iv) repairs conducted outside recommended specifications, v) subpar workmanship, and vi)

Figure 27. Process Map for Worn.

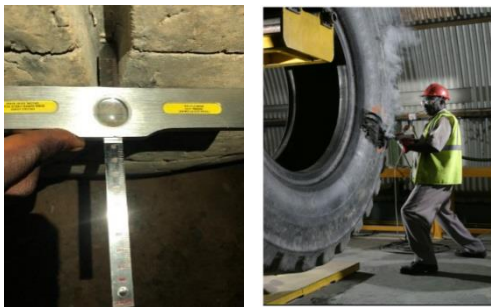
Repairing rubber tyres from Caterpillar haul truck mining vehicle in maintenance workshop to maximise tyre life. Prematurely failed haul truck tyres that are not spoilt repairs are sent to the Mine's maintenance workshop to be repaired and reused. A pneumatic wire brush is used to clean up the damage from the inside of the tyre before repair, as shown in [Figure 21](#). At NAM, the commonly used method for repairing haul truck tyres is the internal patch method. The tyre is checked to identify the damaged location, the damaged area is then planished, and glue is applied around the hole. A special rubber patch is attached to the damaged area and pressed firmly. After that, a layer of protective glue is smeared in the area and allowed to dry. The tyres are then stored for reuse. Repairing old tyres helps maximise tyre life during supply shortages and decreases operational costs. However, the disadvantage of this method is that the damaged parts are easily corroded by rainwater and other pollutants.

**Figure 21.** Haul Truck Tyre Being Repaired at NAM Site.

ating natural degradation due to exposure to oxygen, ozone, and sunlight. Furthermore, the study recommended replacing the internal patch method used for repairing old tyres with a more reliable repair method.
