Comparison of natural frequencies of vibration for a bridge obtained from measurements with new sensor systeme

Nobuhiro Shimoi, Masahiro Saijo, Carlos Cuadra, Hirokazu Madokoro. Comparison of Natural Frequencies of Vibration for a Bridge Obtained from Measurements with New Sensor Systeme. *American Journal of Remote Sensing*. Vol. 2, No. 4, 2014, pp. 30-36.

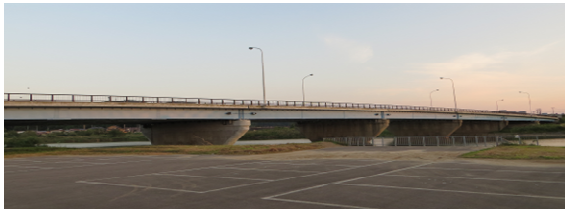
A general view of the structure selected for this study is portrayed in Figure 1. This bridge, called Asuka Ohashi Bridge, was constructed in 1979. It spans the Koyoshi River with its 256 m total length.

Figure 1. General view of the target structure.

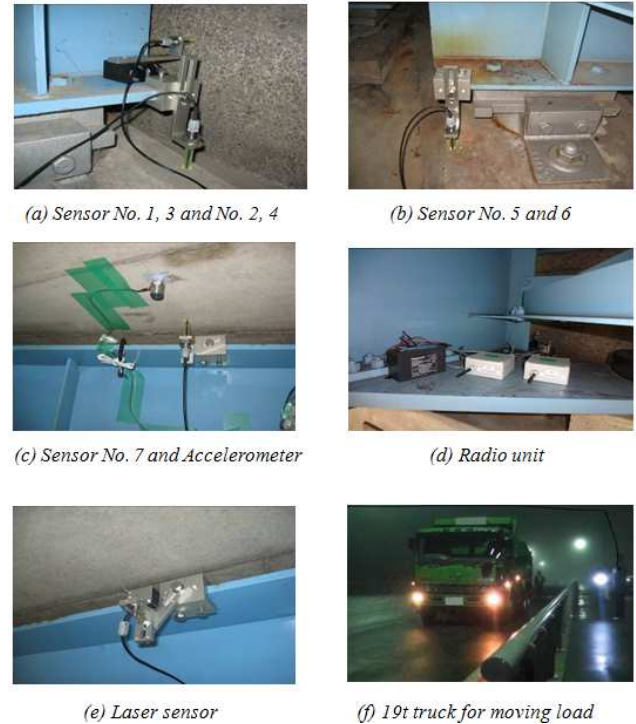
Figure 4. General setup of points of measurements.

Figure 4 presents some details of the sensor setup. Fundamentally, the relative displacements between girders and support structure were measured at each point. For this purpose, sensors were fixed firmly to the girder flange with the end in contact with the support surface. Sensors 1, 2, 3, 4, 5, and 6 were set up for this method as shown in Figures 4(a) and 4(b). Figure 4(c) presents details of the accelerometer and sensor setup at point 7, which is the center of the span. Figure 4(d) shows the wireless transmission unit (radio unit) and corresponding battery. This unit receives a signal from the sensors and sends it to a computer for data acquisition. Figure 4(e) shows the setup of laser the displacement transducer. In addition, vibration caused by moving loads was measured. Figure 4(f) shows the 19 t truck that was used for this test.

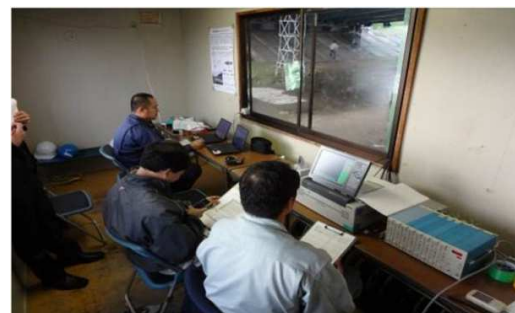
As Figure 7(a) shows, the sensor is connected to a radio unit that sends a wireless signal to a controller that is connected to a computer. The sensor itself requires no input energy. To emit its response, however, the radio unit requires a source of energy. Signals from the sensor can be monitored from an operation room, as shown in Figure 7(b). In this study, a prefabricated portable room was installed near the target bridge to conduct measurements [10] [11].

Figure 7. Sensor signal transmission and general layout of control room.
