Experience: An Oil Spill from a Crude Oil Pipeline

Huseyin Murat Cekirge

Department of Mechanical Engineering, the Grove School of Engineering, the City College of the City University of New York, New York, USA

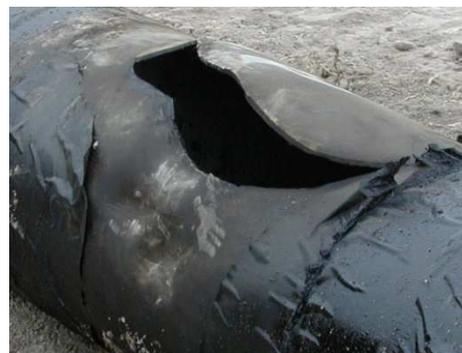
The accident was happened by rupturing 18-inch crude oil pipeline, which previously was removed from the lake area to prevent accidents. The rupturing was happened during earthwork activities, most likely there was a hit from a backhoe, Figures 1-2. Then, oil flowed through an irrigation channel from the ruptured pipeline to the lake. The pipeline administration was not prepared such an event and there were not appropriate equipments in the area. The cleaning crews tried to recover oil by equipments that they could acquire from the local sources. The modern equipment arrived in the area within a week, and modern recovery was initiated and completed.

Figure 1. Ruptured pipeline, [11] and [12].

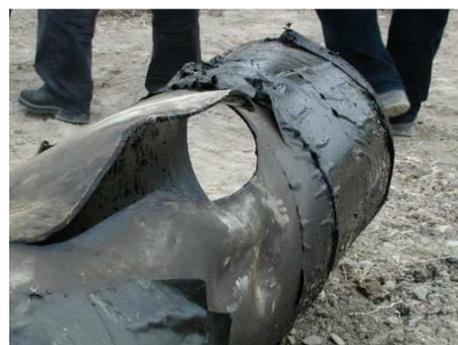
Figure 2. Another view of ruptured pipeline, [11] and [12].

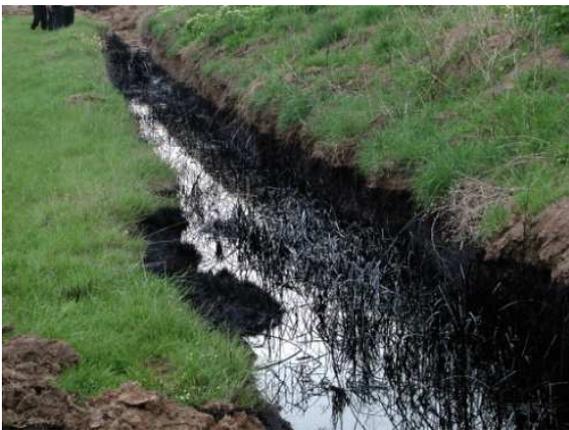
The oil spill started from a ruptures pipeline during earth works in the area. The spilled oil found its way to the dam lake through an irrigation channel used for adjacent agricultural areas. Unfortunately, the shutting down the valves were delayed around six or seven hours, Figures 3 - 8. The channel was located, closed and boomed to prevent further flow of oil from the ruptured pipeline. The pipeline is repaired for oil transportation from the oil field. The accident happened in a remote area, a trailer was furnished as a command room for IC (Incident Command) operations, Figures 9 – 10. The movements of oil was observed bu using three percent law of oil spill movements on water; and the wind vector was obtained from local authorities and/or guessed by looking at local conditions for deployment of manpower and equipment. There was no computer related help at beginning.

Figure 3. Irrigation channel, [11] and [12].

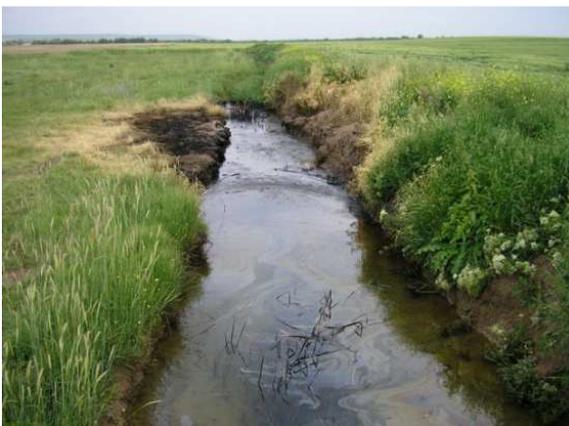
Figure 4. Oil flowing through the irrigation channel, [11] and [12].

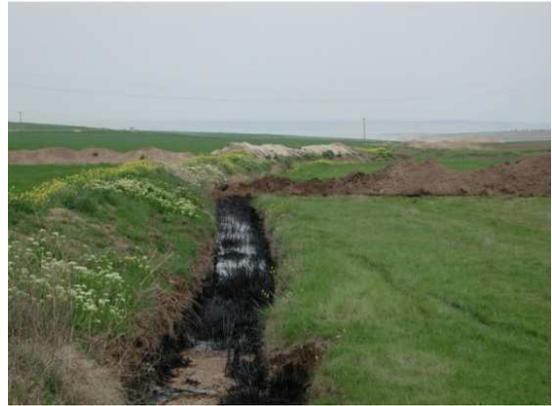
Figure 5. Another view of the irrigation channel, [11] and [12].

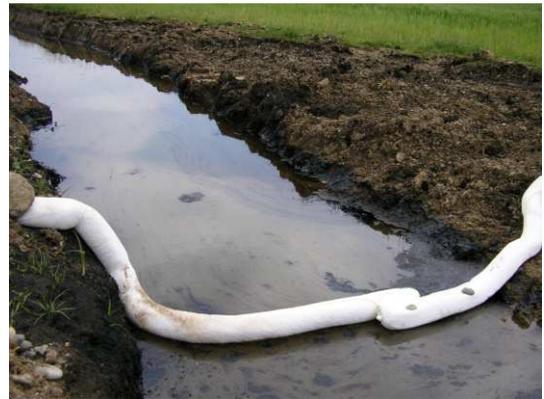
Figure 6. Boomed channel, [11] and [12].

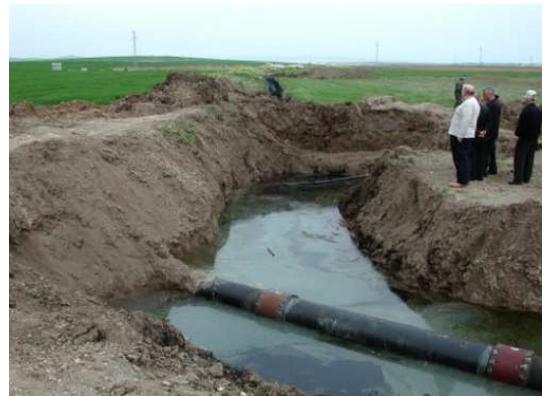
Figure 7. Repaired pipeline, [11] and [12].

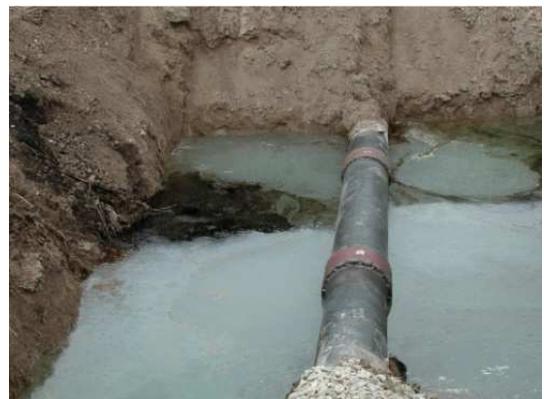
Figure 8. Another view of repaired pipeline, [11] and [12].

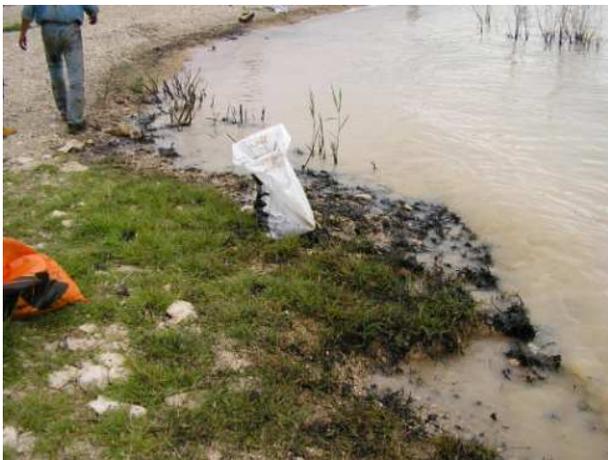
The oil spread to various areas was located; and necessary actions were taken to recover and prevent oil further spreading, Figures 11-14.

Figure 11. Oily shoreline, [11] and [12].

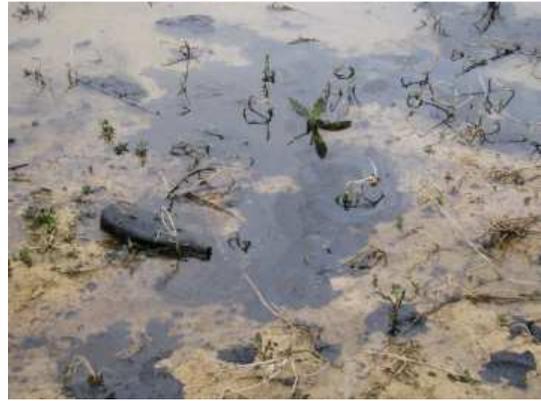
Figure 12. Oil and debris on the water, [11] and [12].

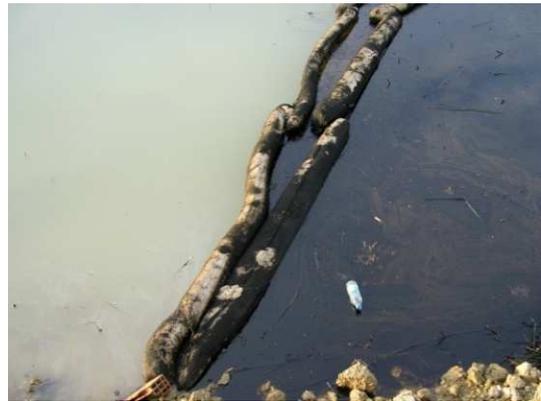
The coves on the shore areas were immediately boomed to prevent spreading oil from these secluded areas. The skimmers were employed to get oil out of water, Figure 15.

Figure 13. Keeping oil inside a cove, [11] and [12].

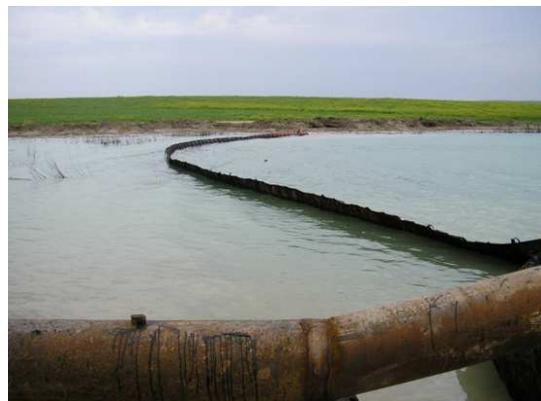
Figure 14. Booming an area to stop further movements of oil, [11] and [12].

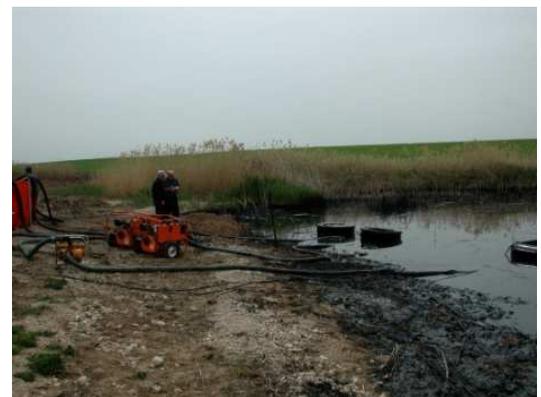
Figure 15. Working skimmer on the oily shoreline, [11] and [12].

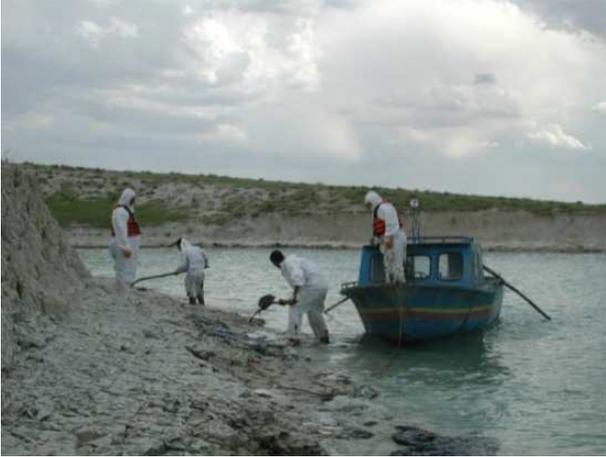
Figure 16. Hand cleaning the shoreline, [11] and [12].

Some areas were very difficult and the only choice was hand cleaning, Figure 16 - 17. The organizing and managing the hand cleaning operation was quite complicated and expensive. This method can only be viable if there is no other choice.

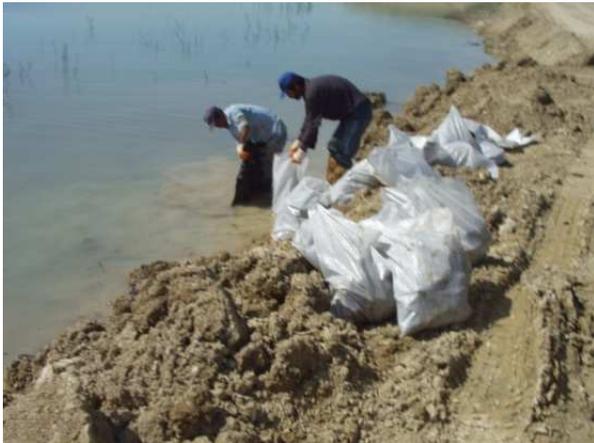
Figure 17. Collecting debris, [11] and [12].

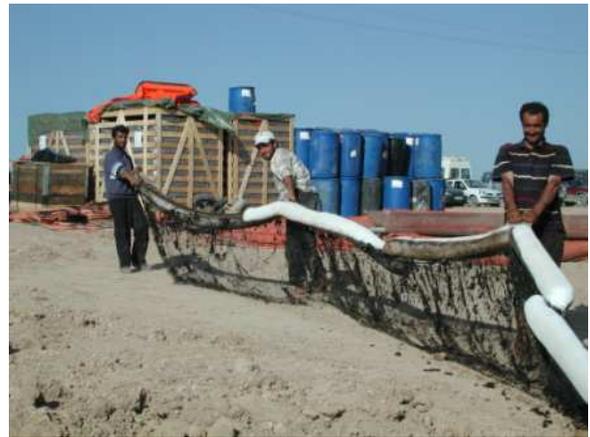
A fishnetted booms were prepared and used to recover oil from water surface. They were used to collect oil on the water; and also in the water column, Figures 19 – 22. They were very useful when the modern skimmers were not on the scene.

Figure 19. The fishnetted boom prepared for oil collection, [11] and [12].

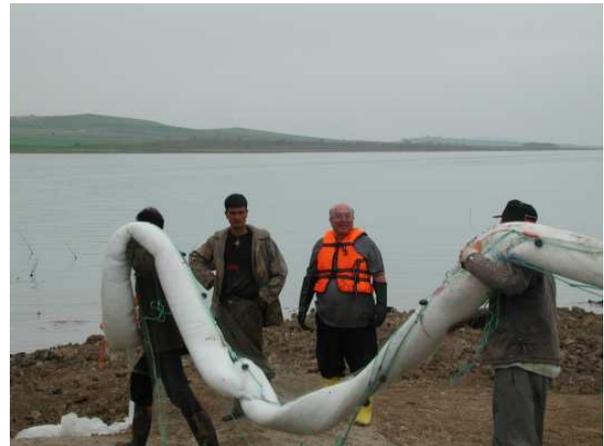
Figure 20. The fishnetted boom to the water for oil collection, [11] and [12].

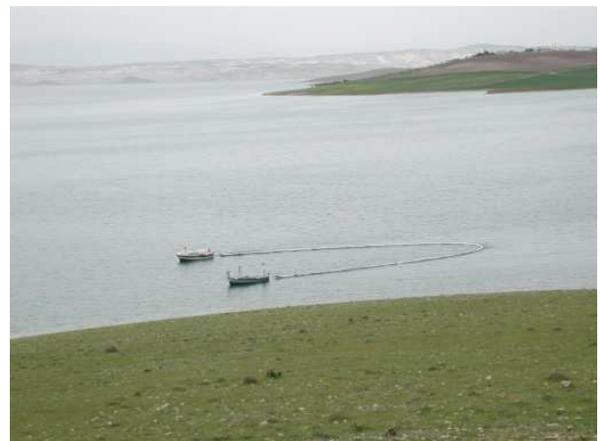
Figure 21. A fishnetted boom in oil recovery from the lake waters, [11] and [12].

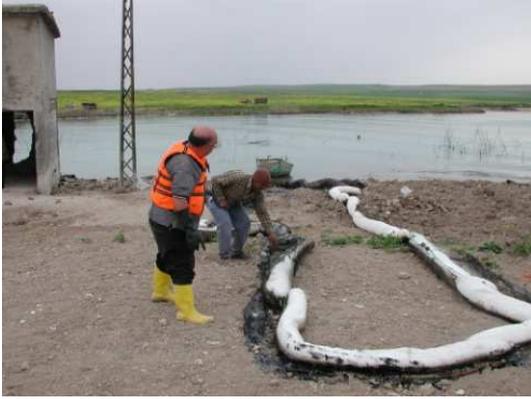
Figure 22. Returning boom with collected oil, [11] and [12].

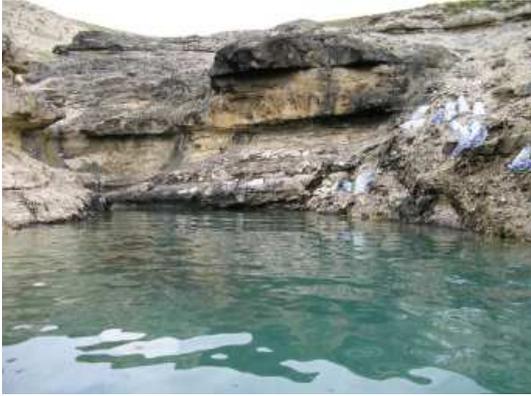
The oil was still in the environment, Figure 23 and hand cleaning that was a very expensive operation was going on. A hand recovery is presented by Figure 24. Modern and new equipments including a boat skimmer arrived in the accident area; and they were started to use for recovery, Figure 25 - 26.

Figure 23. Accumulation of oil on the shore, [11] and [12].

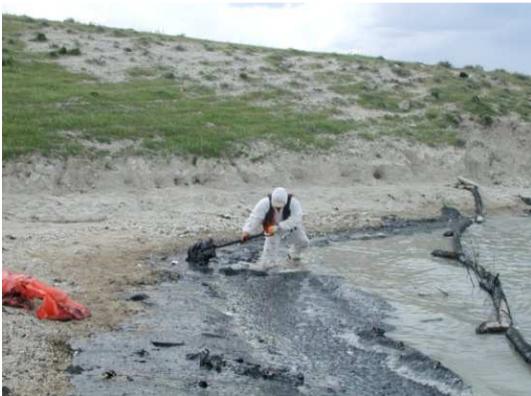
Figure 24. Cleaning the boomed shoreline, [11] and [12].

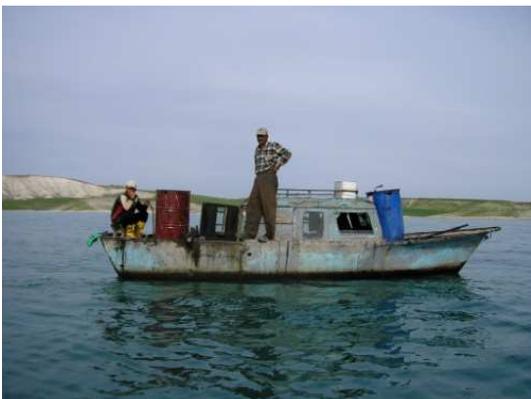
Figure 25. A local recovery boat, [11] and [12].

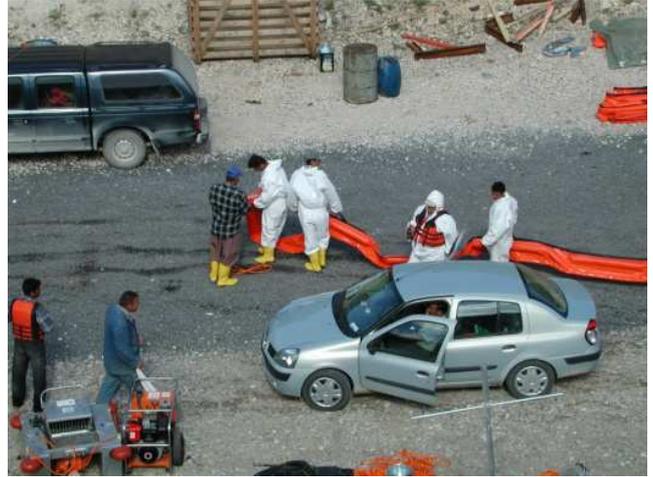
Figure 26. New and modern equipments were in the area, [11] and [12].

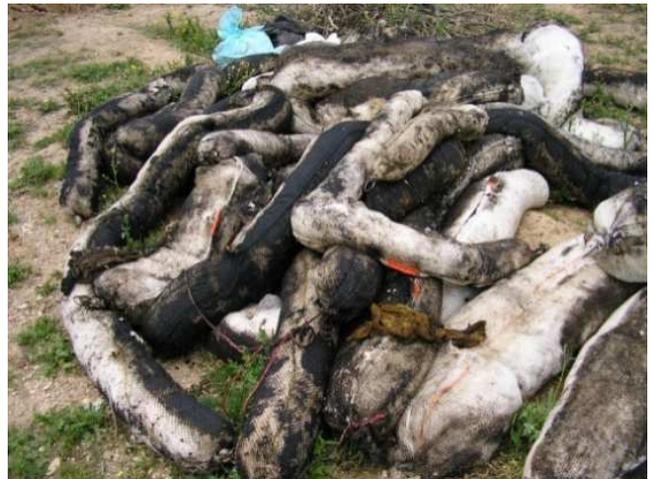
The oil collecting materials and debris are presented by Figures 27- 30. The equipment and materials must be repaired; and cleaned for reusing and recycling, Figures 31 -32.

Figure 27. Oily booms, [11] and [12].

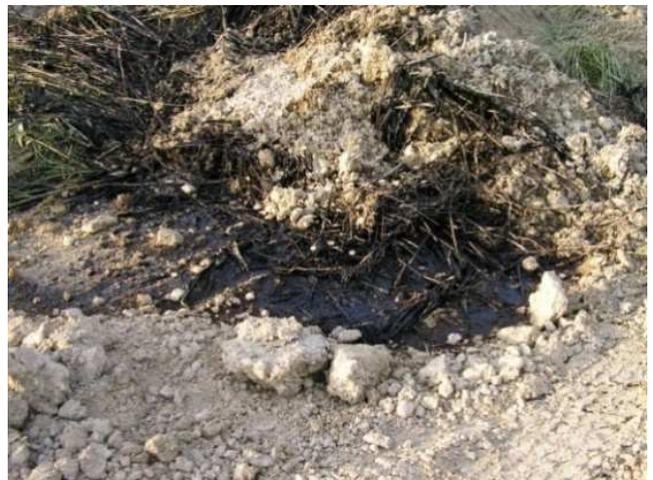
Figure 28. Oiled stones on the shore, [11] and [12].

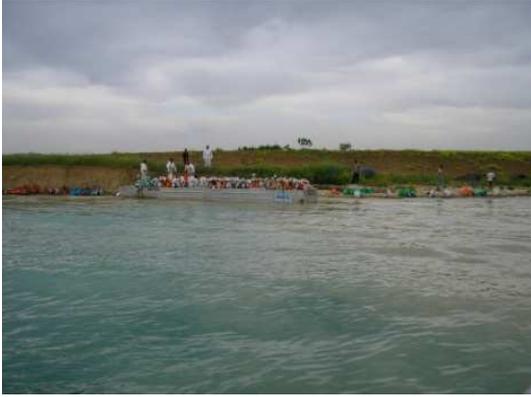
Figure 29. Shoreline and oily debris, [11] and [12].

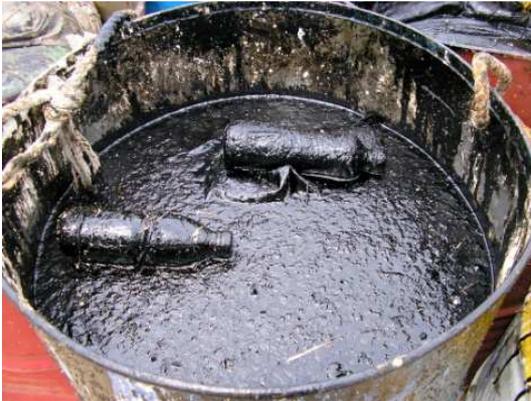
Figure 30. Collected oil, [11] and [12].

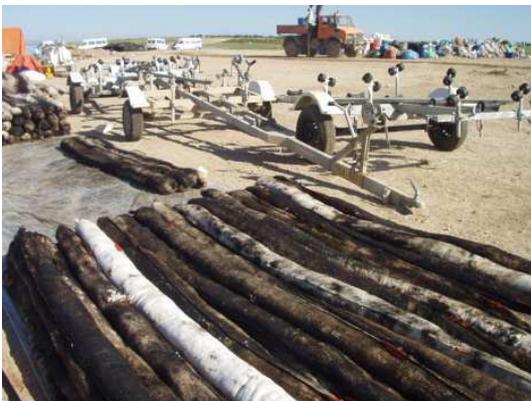
Figure 31. Preparing booms for reuse, [11] and [12].

The equipments are in quite stress, they must be well maintained, repaired and constantly cleaned. There are many different type equipments and they require special expertise and this expertise must be present in the accident area.

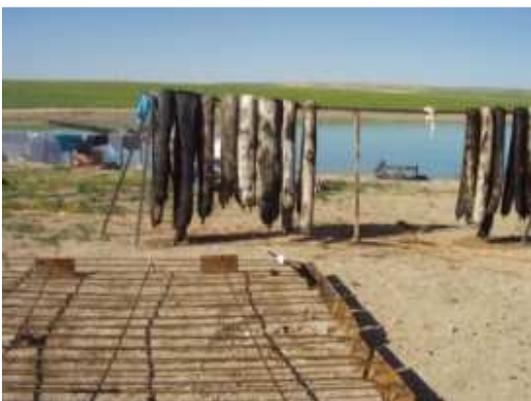
Figure 32. Drying the used booms, [11] and [12].

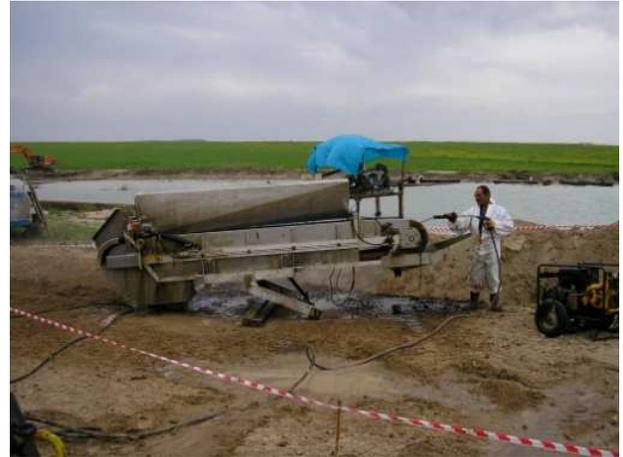
Some of the oil spill response equipments are shown by Figures 33 – 36.

Figure 33. Washing an equipment, [11] and [12].

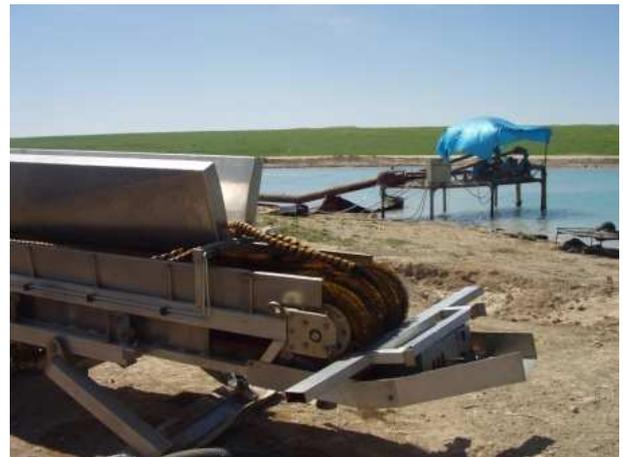
Figure 34. Skimmer on the shore, [11] and [12].

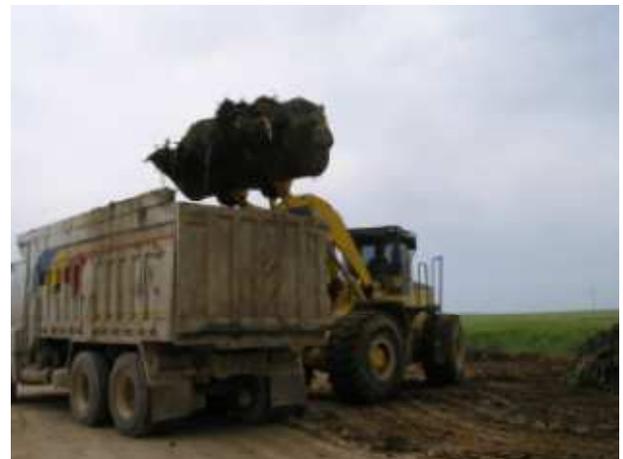
Figure 35. Loading debris, [11] and [12].

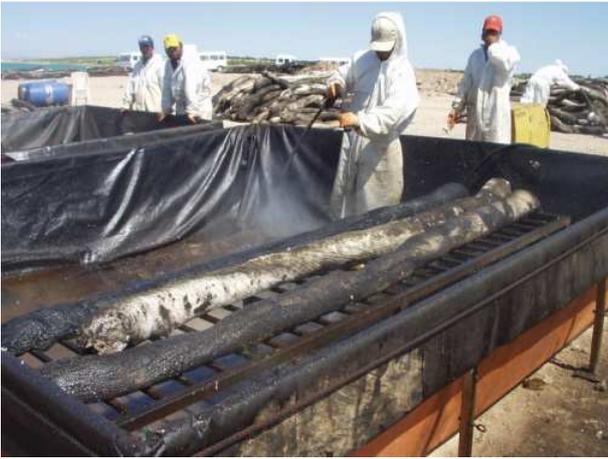
Figure 36. Loading portable storage, [11] and [12].

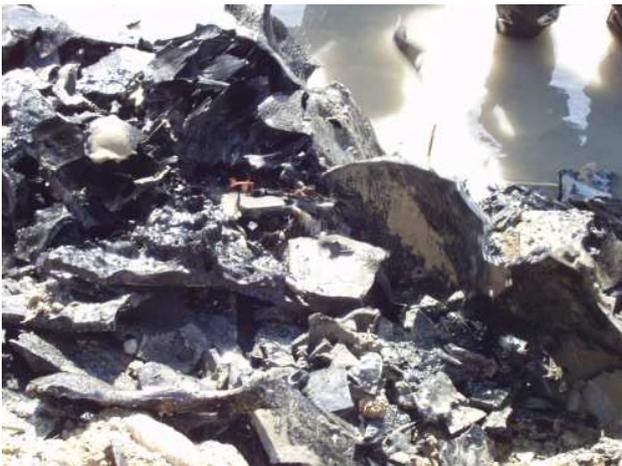
The collected debris was buried in the lined local and nonlocal pits, Figure 37-46. Debris from which oil can be recoverable was transported to organizations that could treat this material. The oil directly recovered from the spill was sent to a refinery that could process this kind weathered oil.

Figure 37. Hardened oil, [11] and [12].

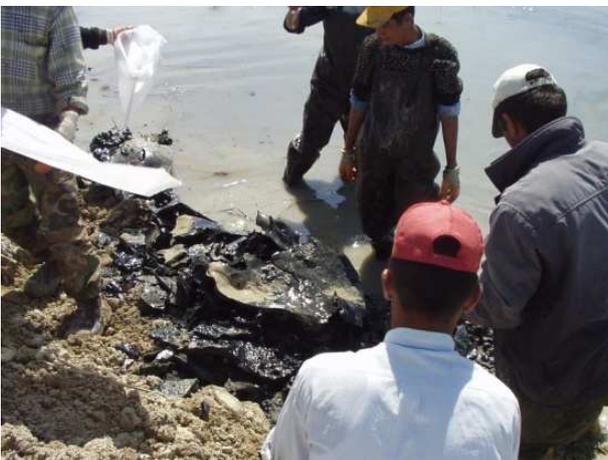
Figure 38. Recovering hardened oil on the shoreline, [11] and [12].

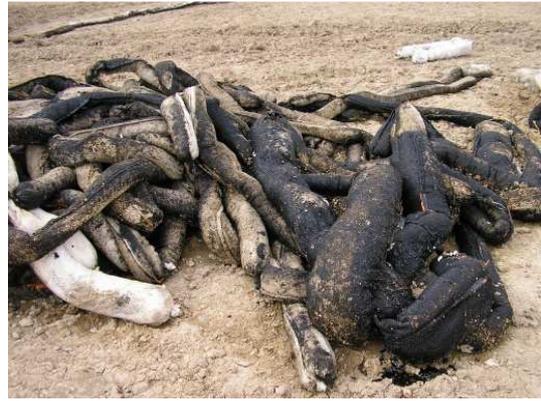
Figure 39. Unusable oily booms on the shore, [11] and [12].

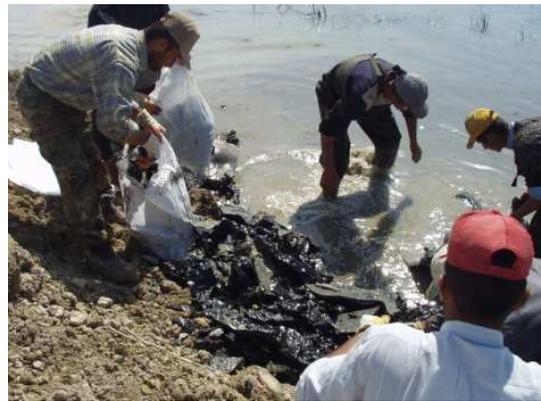
Figure 40. Recovering more oil, [11] and [12].

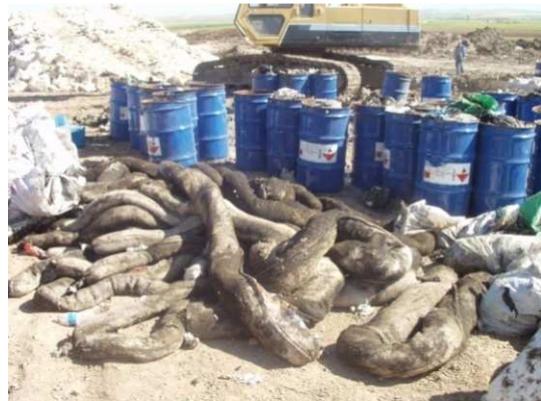
Figure 41. The collection barrels and the oily booms, [11] and [12].

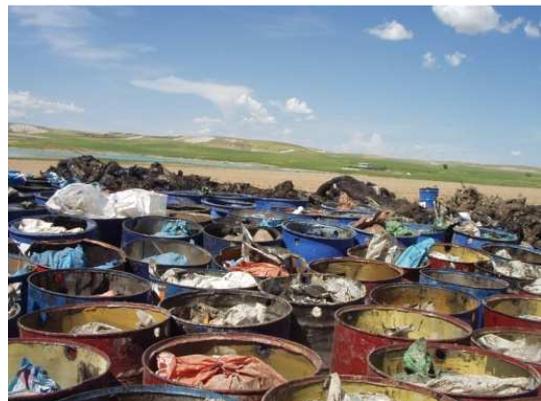
Figure 42. More debris in barrels, [11] and [12].

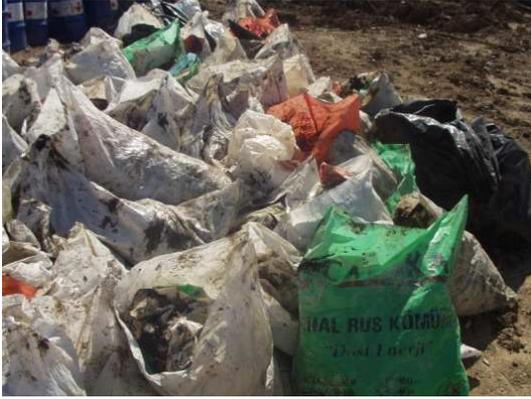
Figure 43. Another pile of debris in bags, [11] and [12].

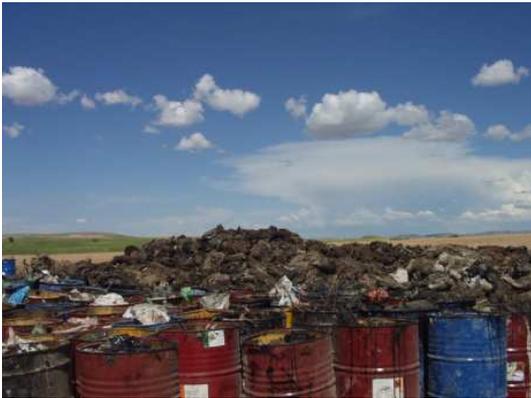
Figure 44. Debris field and barrels, [11] and [12].

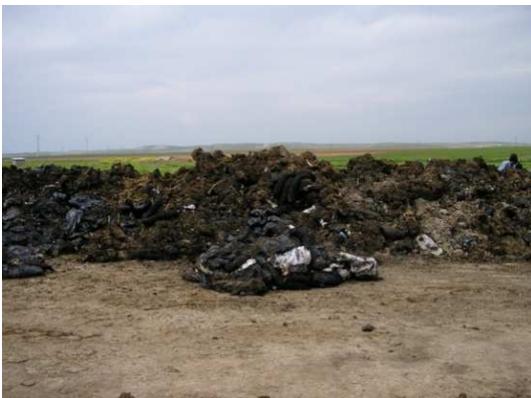
Figure 45. Another view debris storage, [11] and [12].

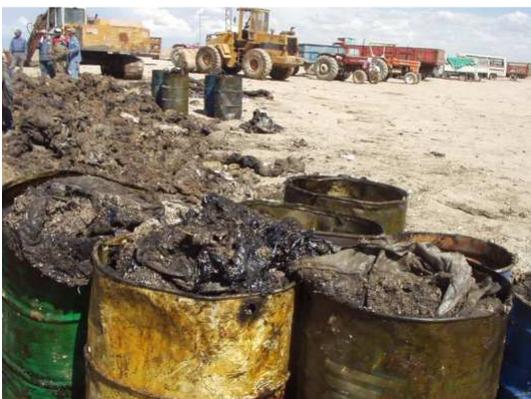
Figure 46. Barrels loaded by debris, [11] and [12].

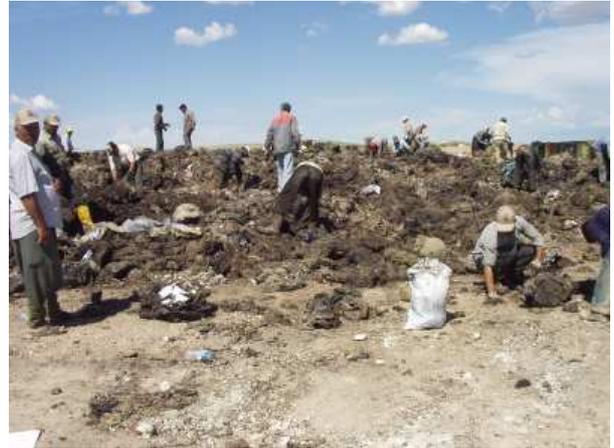
The selected debris storage area must not interact with any environmental concerns; these are air, water, land and living habitats. In addition, the lining of the debris area must be designed that can take all environmental stresses. The debris area must be organized properly for using in the designated area properly, Figures 47 – 50. The post cleaning operations will continue even after careful cleaning operations performed in the area, Figures 51 – 52.

Figure 47. Debris area, [11] and [12].

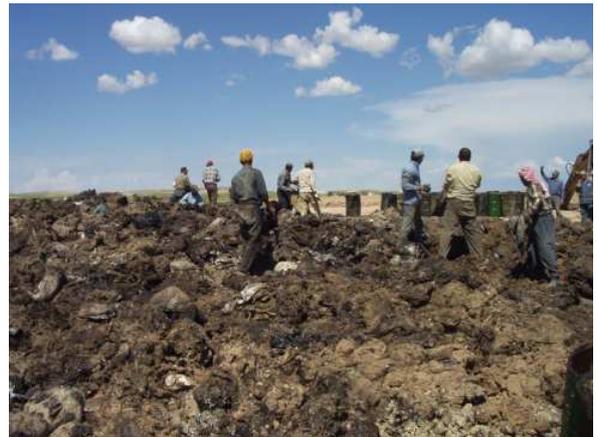
Figure 48. Another view of the debris area, [11] and [12].

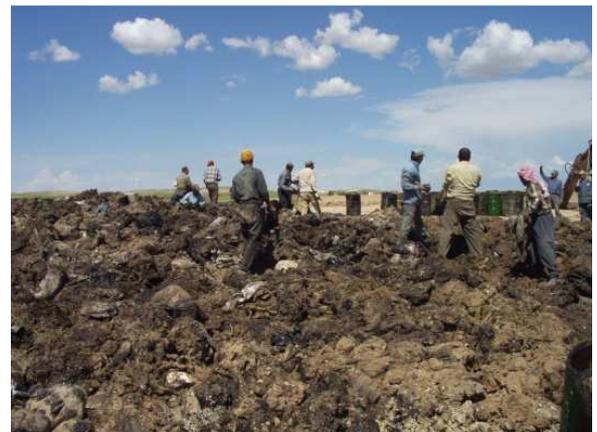
Figure 49. Organizing debris field, [11] and [12].

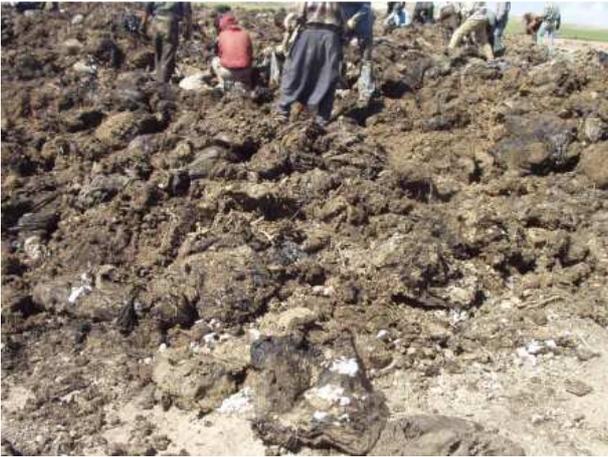
Figure 50. Another view for organizing debris, [11] and [12].

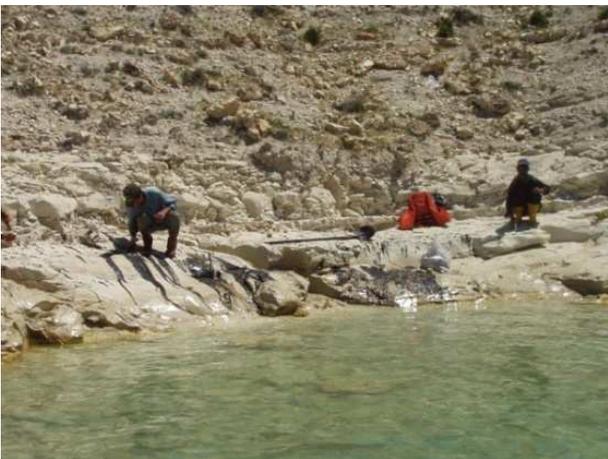
Figure 51. Cleaning stones on the shoreline, [11] and [12].

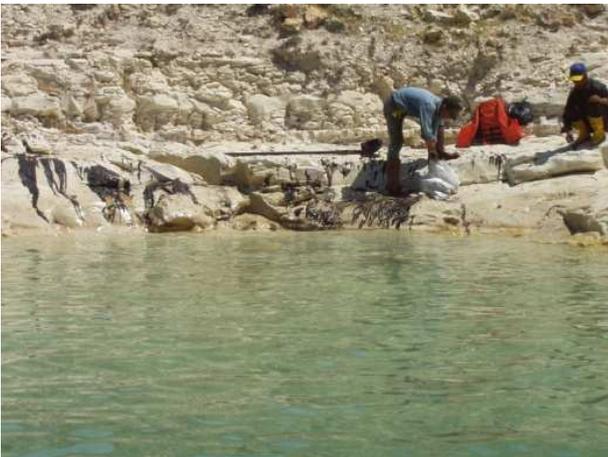
Figure 52. Another view cleaning stones, [11] and [12].

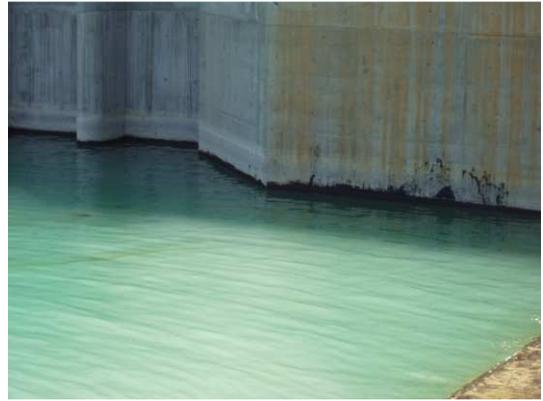
The accident area should be inspected for further cleaning even after cleaning the area. In these situations, there are always uncleaned areas, Figures 53 – 58. These areas must be cleaned further. It is of course, some small oil leftovers will be left to time.

Figure 53. An oiled infrastructure, [11] and [12].

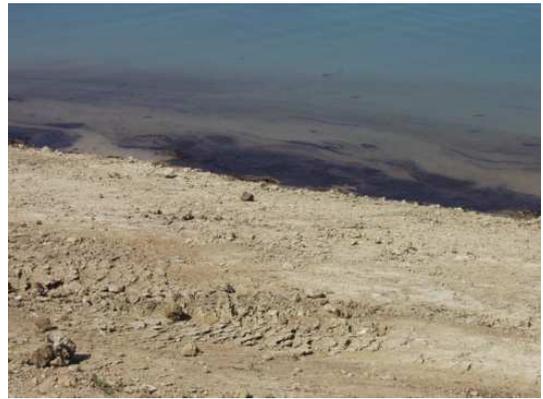
Figure 54. Oil and oil patches on the shoreline, [11] and [12].

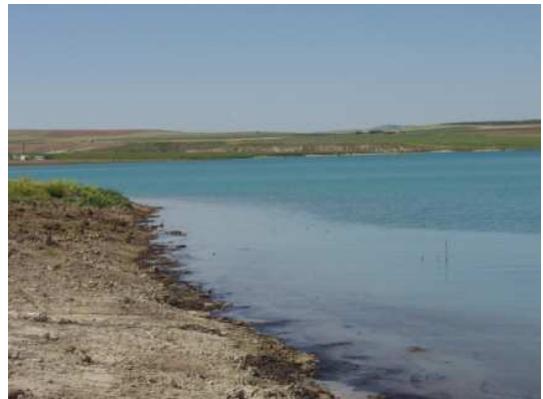
Figure 55. Oil patches on the shoreline, [11] and [12].

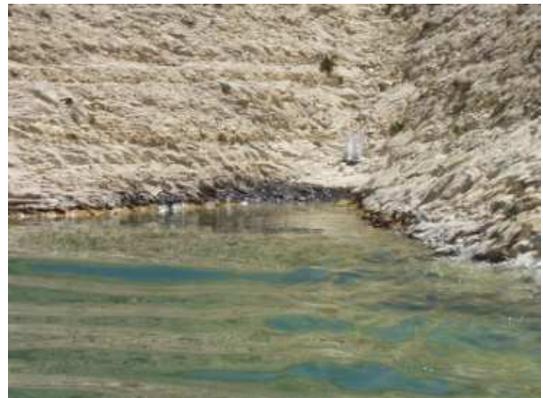
Figure 56. Another oiled shoreline with stones, [11] and [12].

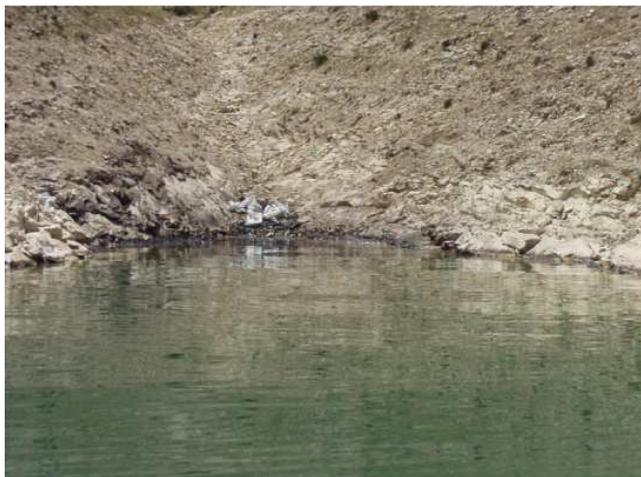
Figure 57. Oiled shoreline with stones, [11] and [12].

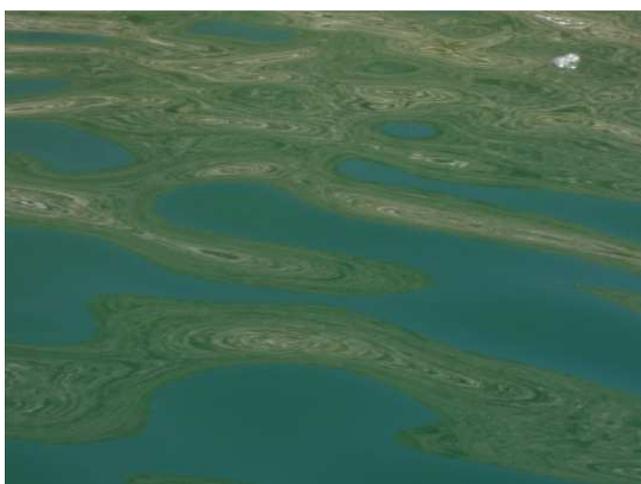
Figure 58. Sheen on the water, [11] and [12].
