The Tubing Destruction Features in Operation of the Gas Condensate Fields with Corrosive Fluids High Content

Nazarii Chaban, Valentyn Myndiuk, Oleg Karpash

Energy Department, National Technical University of Oil and Gas, Ivano-Frankivsk, Ukraine

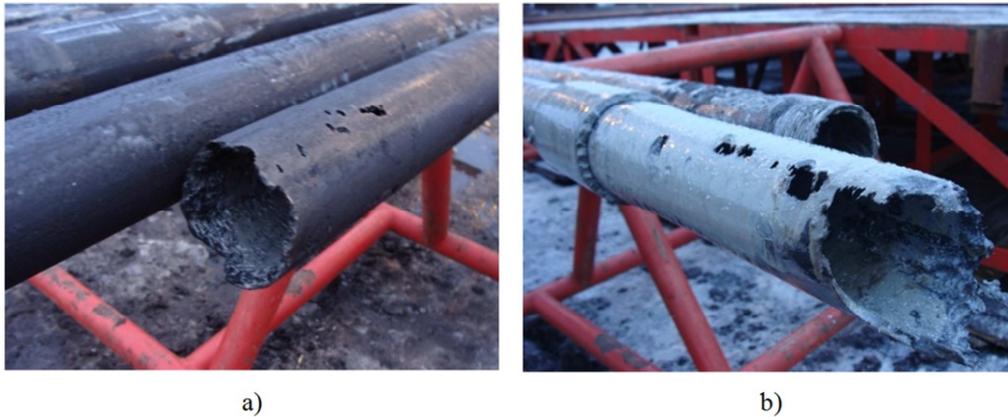
The character of a representative pipe corrosion damages in these conditions, which are typical for condensate fields of

Figure 1. The general view of the typical tubing pipe corrosion damages (a, b) resulting of operation condensate fields by private corporation “Naftohazvydobuvannya”, Ukraine.

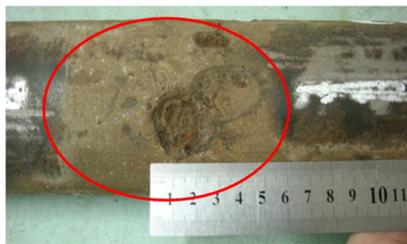
The results of visual and instrumental inspection proved, that corrosion on the surface of tubing pipes has local (zone) nature, corrosion processes occur as on interior as on exterior pipe surface, whereby interior surface has the presence of corrosion deposits in local zones and also pitch zones, and exterior surface corrosion is present only as pitch corrosion. Exterior pipe surface is fully corrosive, general corrosion is coupled with local corrosion zones, damaged with pitch corrosion, in some places causing to occurrence of perforation damages.

(a) local corrosion cavity, full depth 3 mm

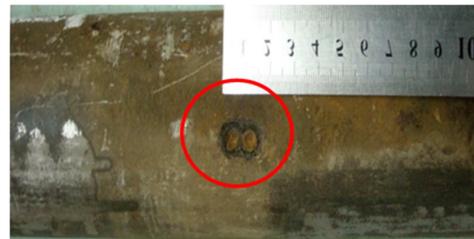
(e) local corrosion cavities of size 8 mm, depth 1,8 mm

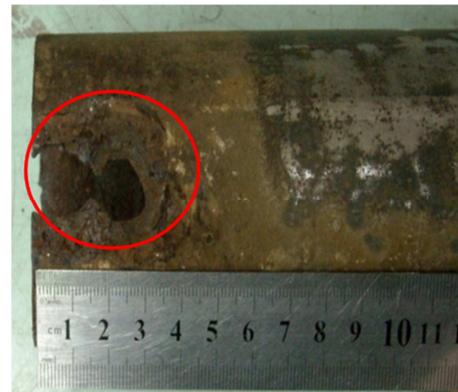
(f) corrosion perforation defect of length 40 mm

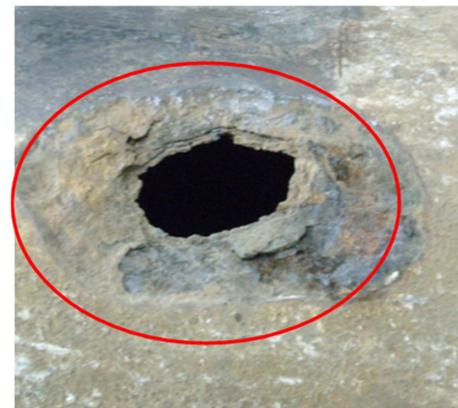
(g) Corrosion perforation defect; effective zone 35 mm, relative mesh dimension 12 mm

Figure 2. *The results of the visual and measuring tubing inspection.*

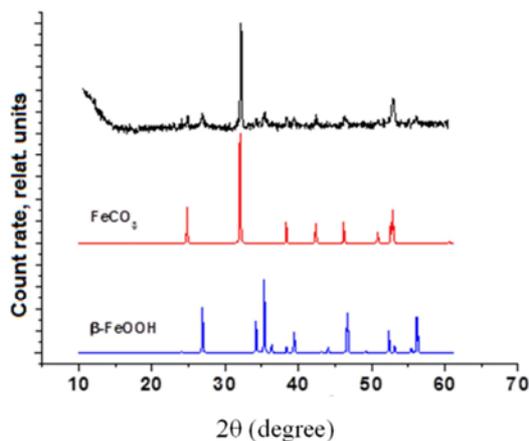
**Figure 3.** XRD pattern of corrosion products on interior tubing surface, and calibration XRD patterns of FeCO₃ and β-FeOOH phases.

Analysis of corrosion products phase composition, received from deposits on the interior tubing surface, showed the presence of two phases of the material (Figure 3). The reflexes, corresponding the crystalline phases FeCO₃ and β-FeOOH are clearly identified on the XRD pattern.

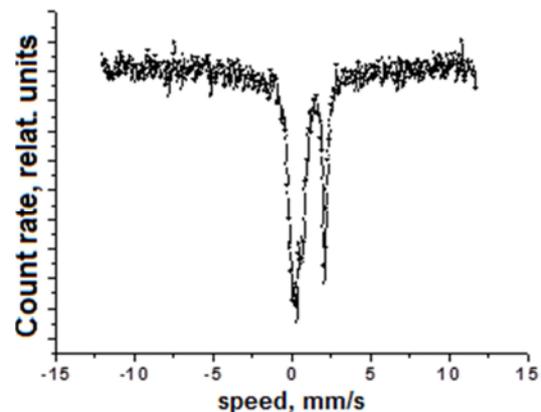
Mössbauer researches verified the results, obtained by X-ray analysis. Mössbauer spectrum of corrosion products, obtained from deposits on the interior tubing surface (Figure 4), is approximated with three doublet lines. Parameters of one of them identically match the ion of Fe²⁺, which are in the structure of FeCO₃. The relative contribution of this component in the integrated intensity of the Mössbauer spectrum is 48%. The other two doublet lines, characterized by similar values isomer shift δ and excellent value of the quadrupole splitting Δ , correspond to the ions Fe³⁺, located in two non-equivalent positions in the crystal structure of β-FeOOH.

**Figure 4.** Mössbauer spectrum of corrosion products on the interior tubing surface.

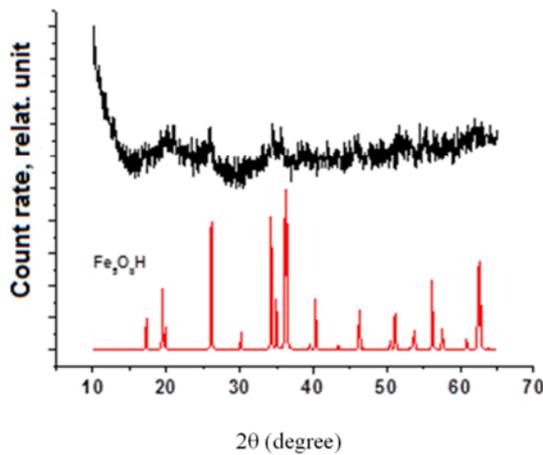
X-ray analysis of corrosion products from pits on the exterior tubing surface of the investigated pipe specimens identified the presence of ferrihydrate (Figure 5). Low intensity broad reflexes, presented on the XRD pattern, identify the low degree of material crystallinity, which is characteristic for this phase. Iron ferrihydrate (also known as "amorphous iron oxide" or "aqueous iron oxide") is a unstable polymorphic modification iron hydroxide, widespread in natural conditions, which eventually turns into a more stable phase of gothite (α -FeOON) and hematite (α -Fe₂O₃). Ferrihydrate is the simplest form of iron oxidation; the crystal lattice is represented by Fe₅O₈H·H₂O, Fe₅O₈·4H₂O or Fe(OH)₃. Ferrihydrate equilibrium reaction depends on the environment pH and in case of low crystallinity described as follows:

Figure 5. XRD-pattern of corrosion products on external tubing surface.

Data analysis of X-ray inspection (Figure 5) and Mössbauer spectrography (Figure 6) indicate the soundness of carbon dioxide corrosion on the exterior tubing surface, as there are no direct contact of the metal surface and dissolved carbon dioxide gas, as a result, no iron carbonate ($FeCO_3$) is formed. Local pitch corrosion, in this case, is caused by the impact of galvanic couplings on the metal surface and forming the ferrohydrate phase according to the reactions:

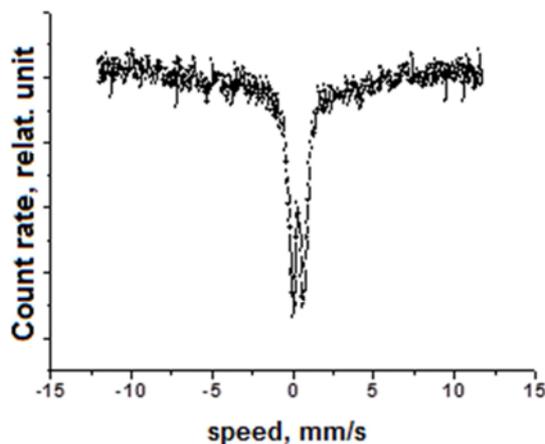
Mössbauer spectrum of corrosion products on the exterior tubing surface (Figure 6) is approximated by two doublet lines, meeting the resonant absorption γ -quanta by nuclei Fe³⁺. Two doublet lines correspond to two non-equivalent position of Fe³⁺ ions in octahedral (Fe₂O·OH)₆ and tetrahedral (Fe₂O·OH)₄ environments in the structure Fe₅O₈H.

Figure 6. Mössbauer spectrum of corrosion products on the exterior tubing surface.
