Effect of Microstructural Variation of a Martensitic Stainless Steel on High Temperature Degradation Behavior

Giselly Bandeira Gomes Dias De Lima, Marcio Roberto Da Rocha. Effect of Microstructural Variation of a Martensitic Stainless Steel on High Temperature Degradation Behavior. *International Journal of Materials Science and Applications*. Vol. 10, No. 6, 2021, pp. 129-133. doi: 10.11648/j.ijmsa.20211006.11

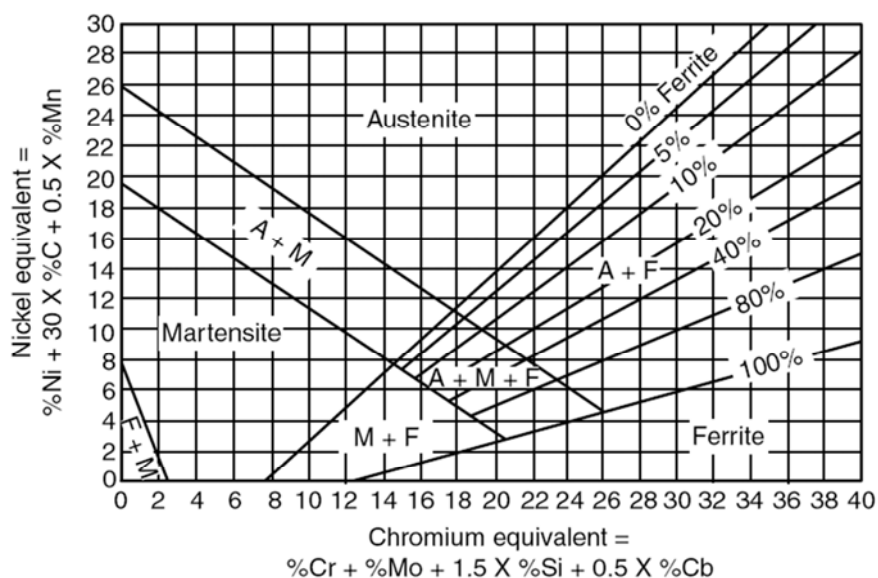
Figure 1. Schaeffler diagram. Chemical composition regions of different families.

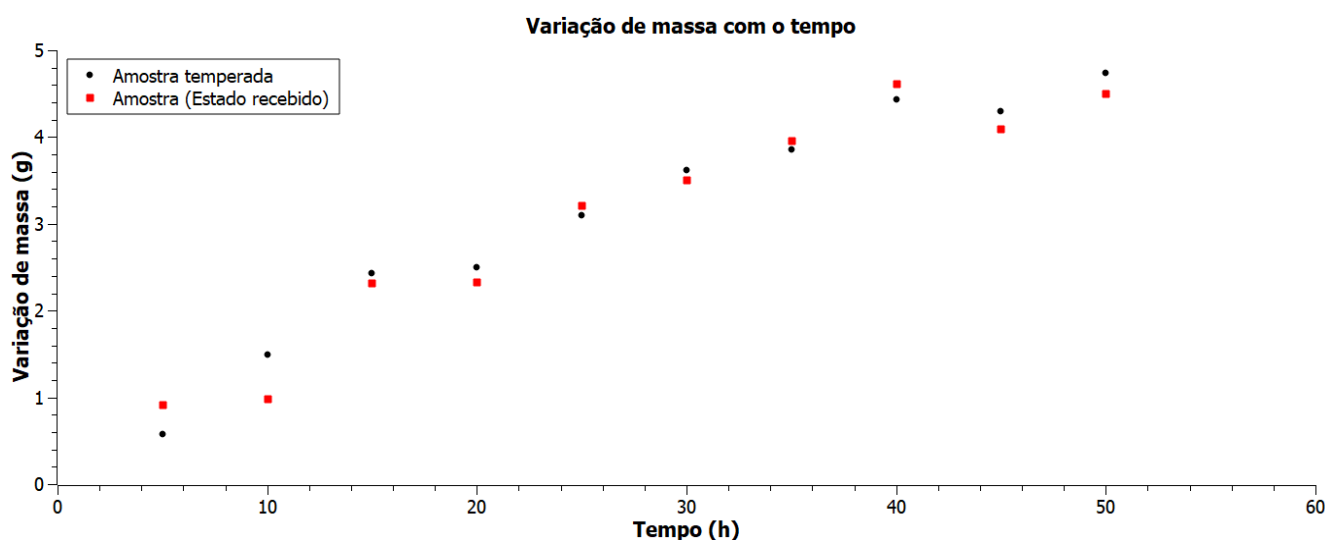
Figure 2. Mass variation with time after fireside corrosion test at 900°C in variable times.

The result of mass gain over time is shown in Figure 2.

In this graph, it is observed that although the variation between samples is different, there is a gradual increase in the mass variation in the samples, due to the increase in the oxide layer formed. Furthermore, even the samples presenting different microstructures, it can be verified that the process is controlled by the oxygen diffusion [9] through the formed layer. This is the main factor that determines the speed of formation of the oxide layer. As the thickness increases, the distance of diffusion through the oxide increases, which justifies the reduction of the oxide layer formation kinetics.

It is also observed that there is no great variation in mass gain between the two materials with different structures. The greater the gain in mass, the greater the tendency of the material to undergo oxidation, as the gain in mass is the result of an accumulation of an oxide layer deposited on the surface of the material.

structure. While the samples in the received state remained with a coarser structure. Thus, the tempered samples remained more reactive after the oxidation test, when compared to the samples in the received state. It is notable that in the beginning the kinetics is fast, that is, when the oxide layer formed is not very thick. While this layer is still thin, oxygen reacts with the surface, as the layer becomes thicker, oxygen has to diffuse through the layer to react with the base metal. The thicker the oxide layer becomes, the more difficult it is for oxygen to diffuse through it, and this is noticeable in the graph shown above, that is, it is not the surface reactivity that determines the velocity, but the thickness of the oxide layer.

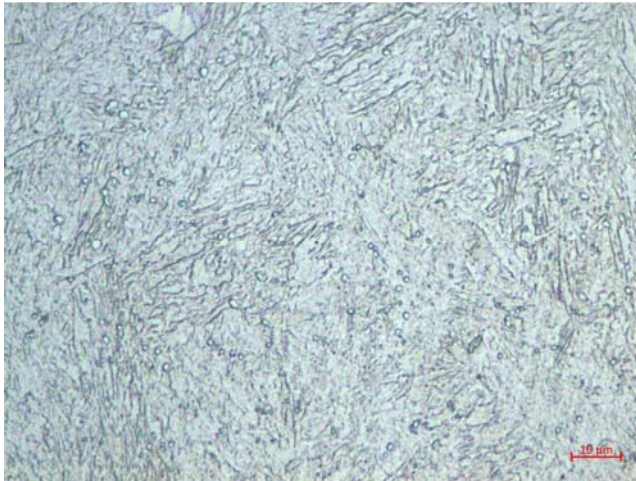
Figure 3. Sample microstructure (received state) after 50 hours in the oven.

In the figures 3 and 4 below, it is observed that the microstructure of the samples after 50 hours in the oven, shows a refined structure, with the presence of Martensite, Ferrite and carbides. However, the received state sample has a higher amount of carbides that, in some parts, form an alignment, being a weakening point for the oxidation process.

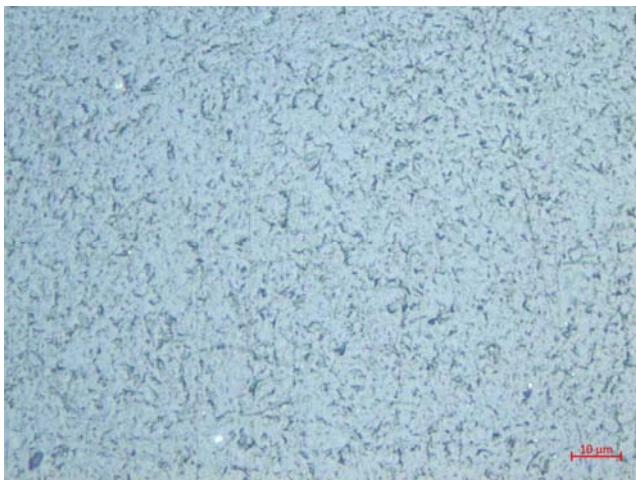
Figure 4. Microstructure of the sample (tempered) after 50 hours in the oven.

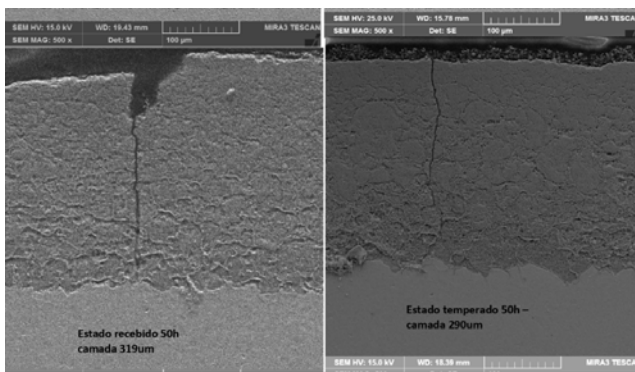
Figure 5. Analysis of the oxide layer in SEM.

Grain size variation was performed so that the austenitic grain size showed variations and different reactivity during oxide formation. The analysis using the Scanning Electron Microscope indicates that the Vanadium has undergone a liquefaction process, diffusing through the material, keeping the traces of the structure. And, it acts on an intergranular corrosion process model. Microstructural variations in the material at a temperature of 900°C over 20 hours do not cause substantial effects.
