# Mine Fires, Experiences in Extinguishing Large Underground Mine Fires

<sup>1</sup>RMU “Banovići” d.d. Banovići, Banovići, Bosnia and Herzegovina

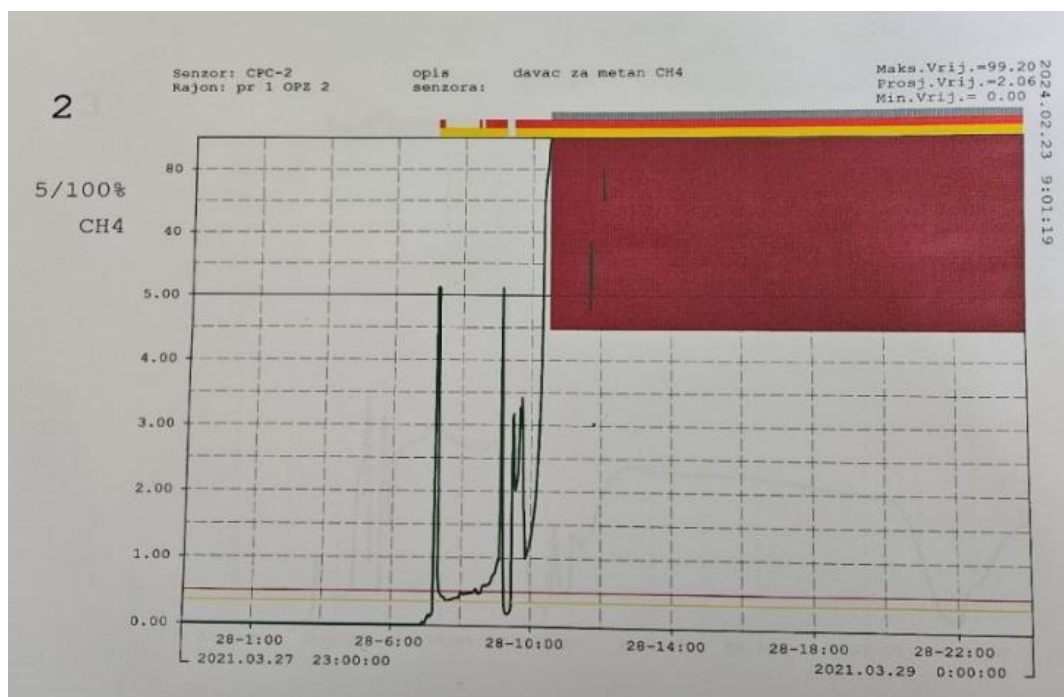
Figure 3. Detector  $\text{CH}_4$  internal number 2.

How strong the fire depression was in the beginning is shown by the concentration of methane on detector 2. Under normal pit ventilation conditions, this detector does not register methane [16]. Due to the fire depression, methane is released from the goaf into the room through the pillar and the insulating wall.
