# Bridge Safety Dangers-Fatigue Cracks, Brittle Failures and Grit Blasting

**Robert Allan Leishear**

Robert Allan Leishear. Bridge Safety Dangers-Fatigue Cracks, Brittle Failures and Grit Blasting. *Journal of Civil, Construction and Environmental Engineering*. Vol. 6, No. 2, 2021, pp. 28-45. doi: 10.11648/j.jccee.20210602.12

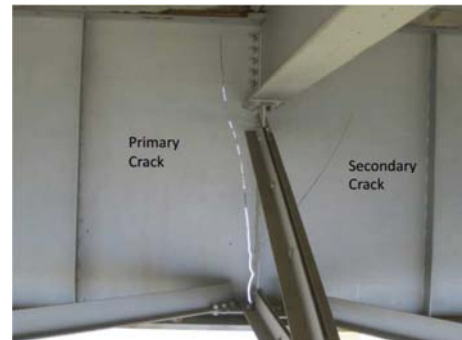
**Figure 8.** 2011 Diefenbaker Bridge cracks [17].

For the Diefenbaker Bridge, fatigue cracks were found on other bridge spans, indicating that an initial fatigue crack triggered the larger brittle failure crack. Also, brittle fractures have been attributed to initial fatigue initiation [18], and the effects of grit blasting on fatigue deterioration were not considered in this bridge failure investigation by Connor, et al.

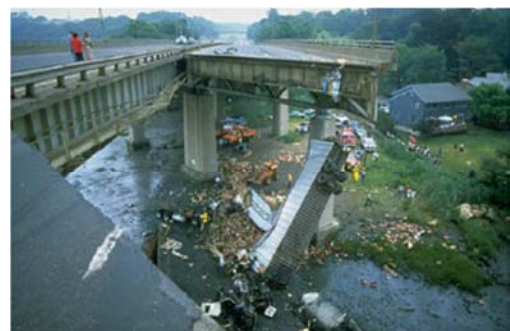
**Figure 11.** 1982 Mianus River Bridge collapse due to corrosion and fatigue [8].

Within the past 45 years, the Mianus bridge collapse was attributed to corrosion and fatigue, where corrosion first damaged a 7 inch diameter pin which was critical to the bridge design (Figure 11). According to reports, when this pin failed due to corrosion, a complex deformation caused the load to double on a second 7 inch diameter pin and caused a fatigue crack failure, and a resultant bridge collapse killed 3 people and injured 3 other people [20].

There was so much corrosion damage that this failure was not well understood, where large cracks in the road surface occurred before collapse. Although grit blasting was unrelated to this failure, fatigue was certainly an issue. Evolving technology is changing fatigue evaluations for multiple industries. The Mianus Bridge collapse 38 years ago

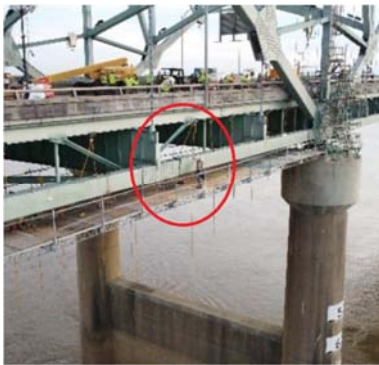
Figure 21. 2021, I-40 Fatigue Crack [36].

This series of two papers has proven that cracks are created by grit blasting, and although the investigation of the Tennessee – Arkansas, Mississippi River I-40 Bridge is far from complete [36], the potential for surface finish to have contributed to this dangerous failure is certainly probable. As shown in Figures 21-24, the bridge experienced a significant failure, where the crack initiated on the bottom surface of the beam at a location located a distance from bolted connections.

In short, the probable cause of the I-40 bridge failure was grit blasting since the bottom beam surface was not welded or bolted where the crack initiated, and given the excessive loads transmitted to the undamaged parallel span, future fatigue cracks are expected. The only question is when that span will crack. This near-collapse of a bridge provides additional proof of theory, and grit blasting demands investigation for this accident.

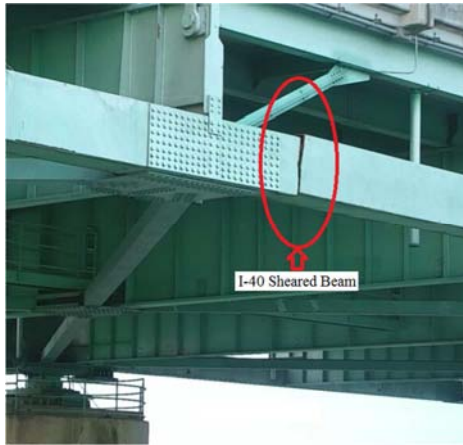
**Figure 23.** May 2021, I-40 Shear of Bridge Beam-Recent Bridge Inspection [36].

The Arkansas Department of Transportation stated that on May 11, 2021, “A routine inspection of the Interstate 40 Mississippi River Bridge (also called the Hernando de Soto Bridge) discovered a mechanical fracture in a steel support beam that is crucial for the structure of the bridge” and further stated that the bridge is “inspected annually because it’s classified as ‘fracture critical’ due to how it’s built”. For a fracture critical bridge, a failure of an affected primary structural beam can cause a bridge collapse since redundant structural beams are not present. Many lives were at risk on the 274 meter long span (900 feet long), since a potential bridge collapse was in process. Note that a steel beam approximately 1 meter high by ½ a meter in width ripped into two pieces. According to the Arkansas Department of Transportation, the fracture started before mid-2019, and according to Fox News “an employee has been fired after a crack on the Interstate 40 bridge over the Mississippi River [that was] visible in a 2019 drone video was missed”. That is the “[Arkansas Department of Transportation Fired an] Employee Over Missed I-40 Mississippi Bridge Crack” [37]. The crack was recorded with a camera on a drone during an earlier inspection, which showed cracks and buckling of non-redundant beams.
