River Pollution in Ethiopia: An Exploratory Assessment of the Causes and Effects on Environmental Sustainability

Keywords: Borkena River, Cause, Effects, Environmental Sustainability, Pollution

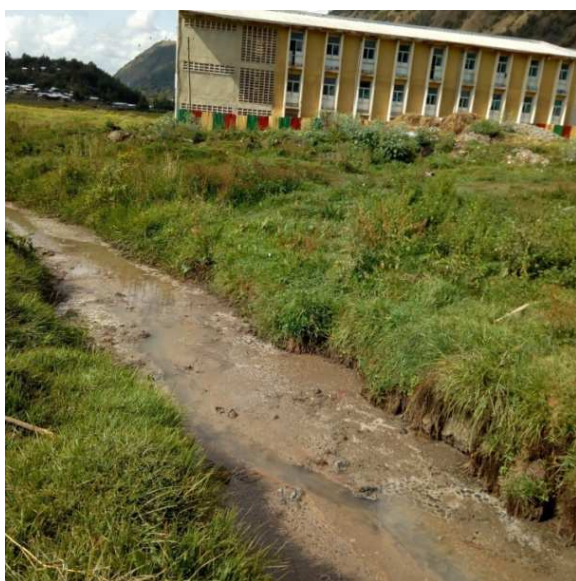
To the east of the University there is swamp of liquid waste and spit blackish liquid. This swamp produces bad smell. The plants grown around this liquid waste were observed died. Except the Universities' waste there is no pollutant actor around that place. Indeed there is septic tank at the south east edge of the University; the researchers observed that small amount of liquid waste relatively different from the pollutant liquid flow via the tank pump. The researchers observed that the septic tank is not properly connected to the sewerage lines, because liquid wastes are run into the river instead of the septic tank.

Figure 2. Liquid wastes from Wollo University.

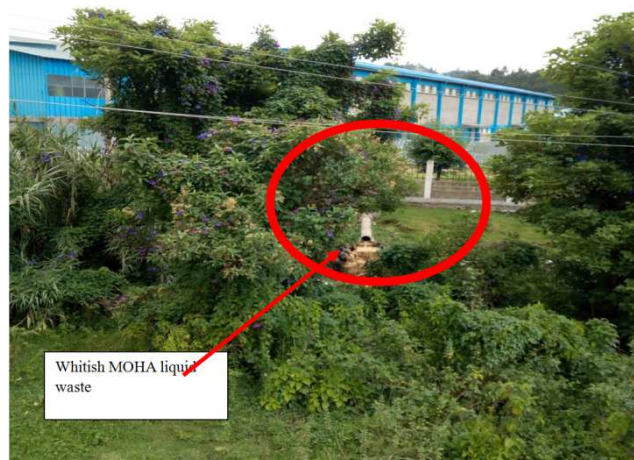
Among eleven Condominium sites in Dessie town, including the university condominium, ten of them release liquid (including toilet waste) wastes in to Borkena River. The Condominiums' septic tank is ill functioning. In most of the sites, liquid wastes create swamp and directly run into the river. Due to these factors, water turned into blackish color. As observed the amount of solid and liquid waste increases as close to the town. There are places where illegal slaughtering/Abattoir service, unprotected toilet, animal waste, garage, river side settlements are observed. Because, river buffer zone is not protected all over the river path. The river buffer zone is under permanent constrictions and business organizations (micro and small enterprises, garages, car wash, floor factory, soft drink factory and shops) directly bordered and attached to the river if not they are on the canal. These companies are alleged for pumping chemical. According to the expert analysis in Buanbuawuha Sub-city, these factories did not have treatment plant and thus release dangerous chemicals like caustic soda, black oil during production and cleaning the factory engine. In addition, the researchers observed that liquid waste canals were directly linked to the river. In the observation, soft drink factory spit whitish fluid which creates accumulated material at its outlet.

Figure 3. Whitish MOHA Factory Liquid Wastes.

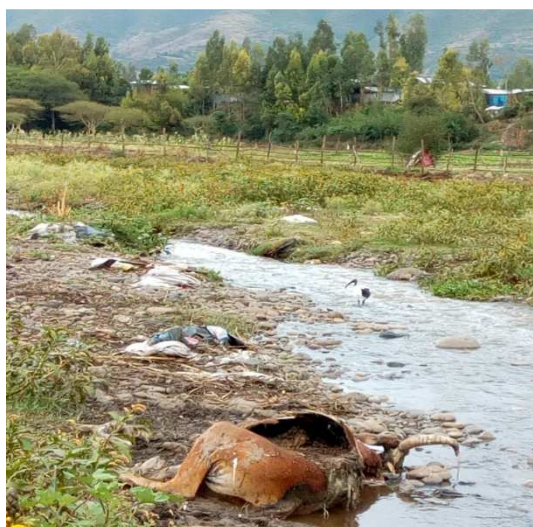
The researchers also observed dead animals, animal waste, bones, remnants of meat factory, barberry wastes, juice houses remnants dumped to Borkena River. Sadly, in the course of the river, a hundred meter below the dead animal picture (dead animal in the river), the researchers observed that youths are bathing, cows drinking, and children and women were fetching water for domestic consumption and other purposes.

Figure 4. Dead Animal and other Solid Wastes at Borkena river Canal (observed in Kombolcha).

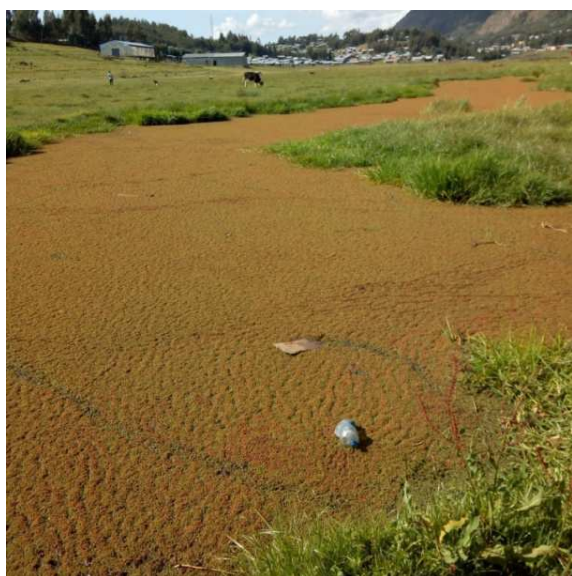
This weed found in Borkena River and other small ponds and tributaries were observed with reddish color that covers the river, ponds and other water bodies of the tributaries from every corner. According to the respondents, this weed was seen for the first time in 2018/19 G.C. The water weed has negative effects on the life of the residents. It (seen in Figure. 5 below) causes the river water to develop bad sniff, muddy materials, cover the water surface and cause water loose. Consequently the alien weed effects to the river pollution causes the residents who are dependent on the river water to suffer from skin etch (especially the children), dried the river water swiftly, which ultimately create water shortage for their cattle drink and agricultural purposes. This effect is mostly observed in the upper stream of Borkena.

Figure 5. Alien Weed (in Borkena River).

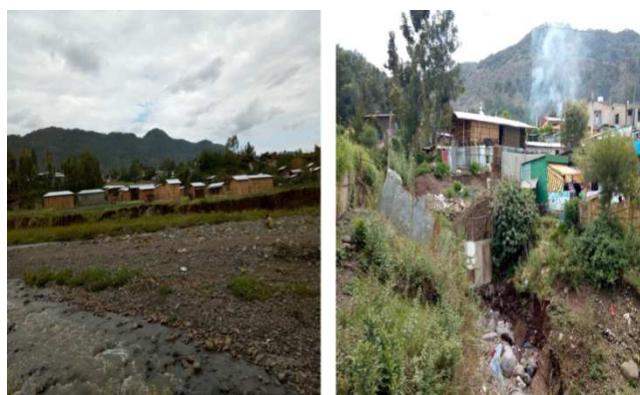
In Borkena River, slums and shanty settlement were observed. Houses were constructed in the riverside where the swampy areas are the sources of water for the river. This is one of the causes that decrease water volume in both the upper and lower river, and worsen shortages of water for domestic and agricultural purposes.

This settlement has brought danger on water sources, and causes the human ecology to be affected by the river pollution and related danger like flood and contaminated and transmitted disease (common cold, influenza). (See figure 6 below).

Figure 6. Informal Settlement at Kombolcha and Dessie Towns (Borkena River) from left to right.

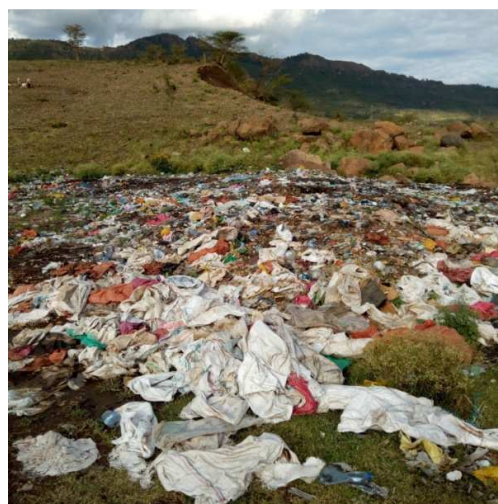
Figure 7. Kombolcha Town Solid wastes dumping area.

Solid waste disposal sites¹, was located in the cliff side of the river in Dessie and Kombolcha towns. The solid waste dumping sites were selected unprofessionally and irresponsibly. Because both sites are found in the jungle or river side where the wastes are producing deadly substance and drained into the river and the forests. Surprisingly domestic animals, wild animals, birds, and street boys and girls collect materials (plastic material, glasses, irons) which will be reused and reprocessed for domestic consumption (plastic bottles for packing locally taped water and food oil) and factory inputs respectively. The research found that, the solid waste disposal site is not appropriate, confirmed by the cities Environmental protection officer. As the researchers observation confirmed, Dessie site (Aziwa cliff) which is found in geologically unstable area caused land slide and cracked cliffs, and the Kombolcha site is nearer to town and farm land too. As a result the waste leach directly flew to the river and farm land of the surrounding farmers.

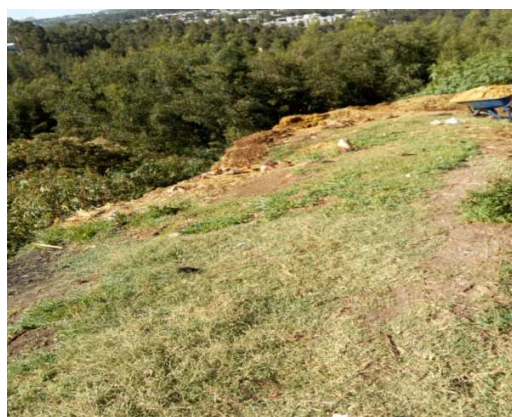
Borkena River affects the community to get clean living environment. Specifically, the abattoirs waste turns the tributary of Borkena to reddish color. So it affects the tributary to lose its water color and cause the local community suffered from health problem. However, the response of government in combating these effects was minimal, almost none.

Figure 8. Dessie Town abattoir Solid wastes dumping area (Borkena River Side).

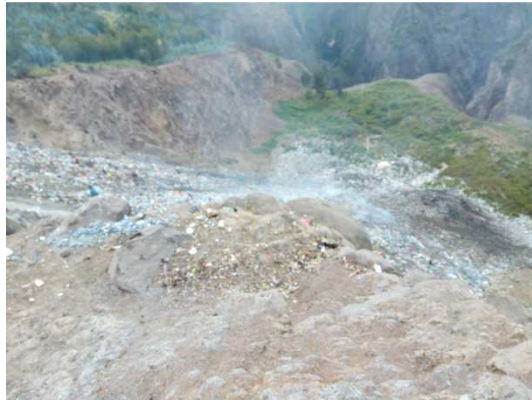
Figure 9. Denbelkeye, Dessie Town Solid wastes Dumping area.

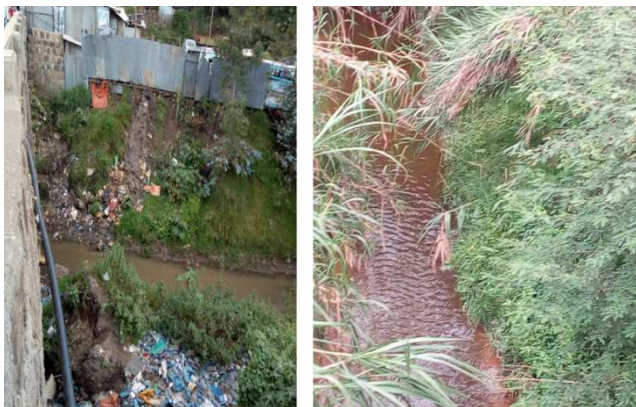
Liquid wastes that caused the river polluted. This is due to lack of liquid waste management system along Borkena river side. Due to this, liquid wastes are directly linked to the flood canals and join Borkena River.

The liquid release of newly built houses, business institutions, resident compounds and institutions causes Borkena and its tributaries polluted. Besides the release of abattoirs, the waste management areas in both Dessie and Kombolcha towns create a swampy area. This in turn proves the management system inefficiency of both local governments.

Figure 10. Liquid Wastes drained to Borkena, from Abattoir and garage at Kombolcha and Dessie town respectively.
