# Analysis and Solution of Flooding Water Problem for EV Passenger Compartment

Dongfeng Motor Corporation Technical Center, Wuhan, China

Li Zhongkui, Xu Zebin, Shu Peichao. Analysis and Solution of Flooding Water Problem for EV Passenger Compartment. *Automation, Control and Intelligent Systems*. Vol. 6, No. 2, 2018, pp. 20-27. doi: 10.11648/j.acis.20180602.11

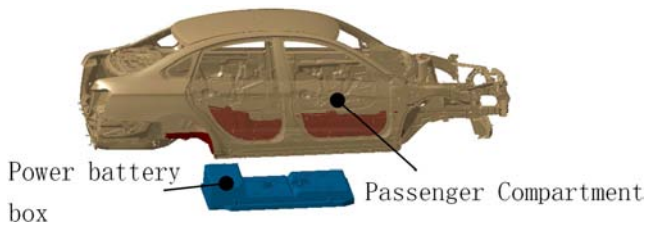
The passenger cabin of electric car and the passenger cabin of traditional car are much the same as little different, the difference mainly lies in the installation of power battery under the floor, resulting in the local bulge of the floor, as shown in figure 1.

Figure 1. EV passenger compartment.

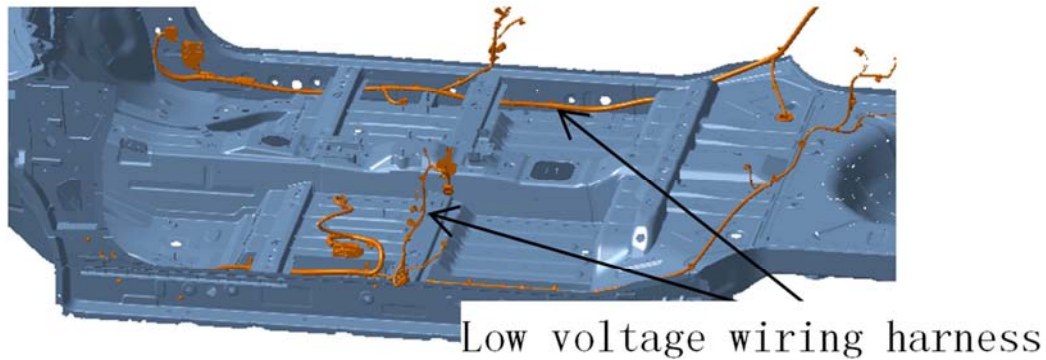
The low-voltage wiring harness layout of passenger cabin is shown in figure 14. The wiring harness is positioned on both sides of the floor and is fixed to the inner plate of the side longitudinal beam by clamping.

Figure 14. Low pressure cabling arrangement in passenger cabin.

The wire harness buckle is also a common clasp, and it is difficult to ensure complete sealing between the mounting hole and the wire harness buckle, as shown in figure 15.

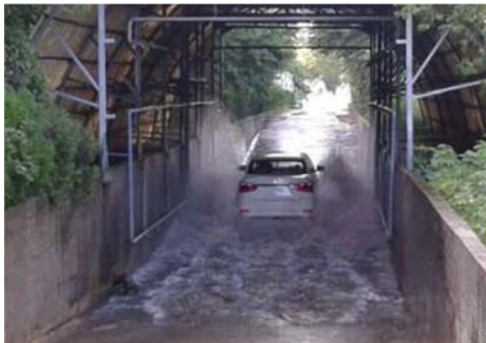
The above solution is applied to the real car, again wading test, respectively into 15 cm deep pools and 30 cm deep pool, as shown in figure 30, 31, running back and forth 10 min, has not found inside the passenger compartment with clear water, show that passenger compartment seal get larger ascension.

Figure 30. 15cm deep water tank wading test vehicle.

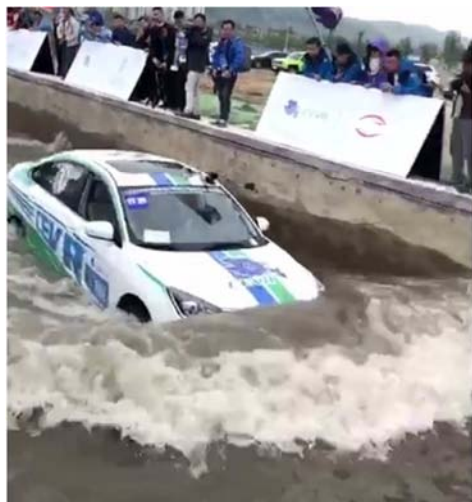
Figure 31. 30cm deep water tank wading test vehicle.
