# Supervisor-Field Engineering Approach (S-FEA) of Determining Tyre Failures in the Haul Trucks at Newmont Ahafo Mine

Department of Mining Engineering, University of Mines and Technology, Tarkwa, Ghana

Haul Truck Tyre Life, Supervisor-Field Engineering Approach (S-FEA), Sidewall Cut, Shoulder Cut, Tread Chunking

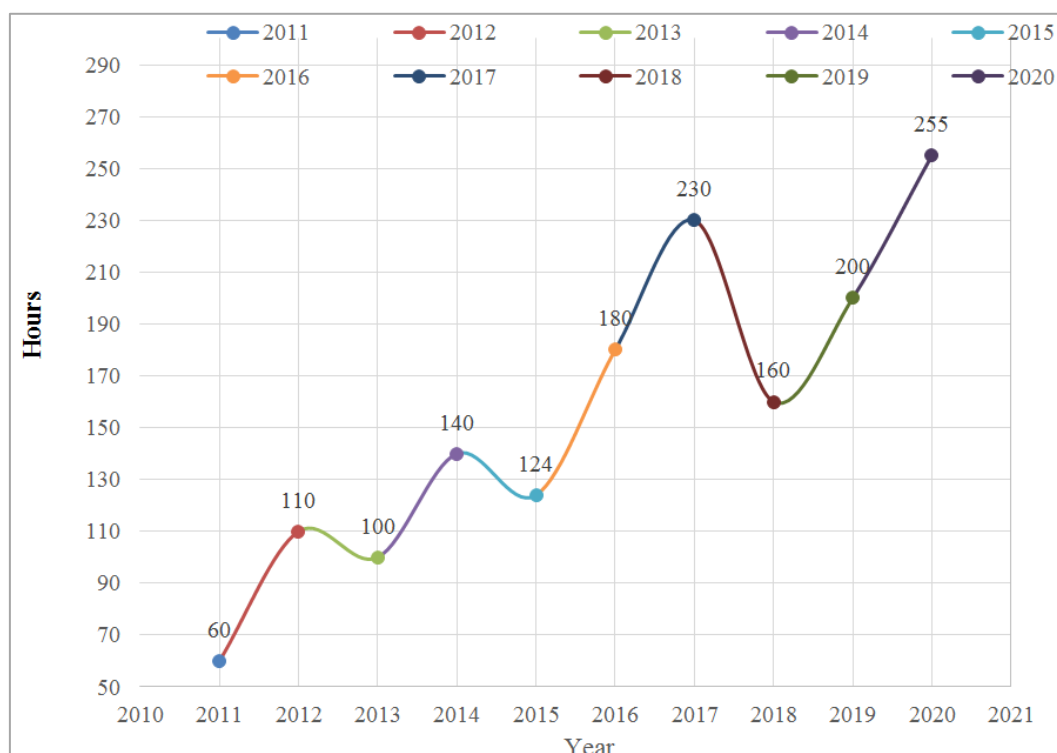
**Figure 3.** Tyre Downtime per Year.

The data analysis in Figure 3 shows the haul truck tyre downtime for the tyres that failed from 2010 to 2020. Generally, the trend of downtime due to tyre failures is increasing from year to year, with the highest tyre downtime being recorded in 2017 and 2020, respectively. This trend is quite alarming and calls for an assessment such as this. It was observed that the extended downtime resulted from the new

tyre size on the mine. Figure 3 shows tyre downtime against failure events. The mode of tyre failures and their frequencies were obtained as presented in Table 1 and graphically illustrated in Figure 3. It is worth noting that all these tyres failed during the period under review without achieving the mine's 7 000 operational hours.

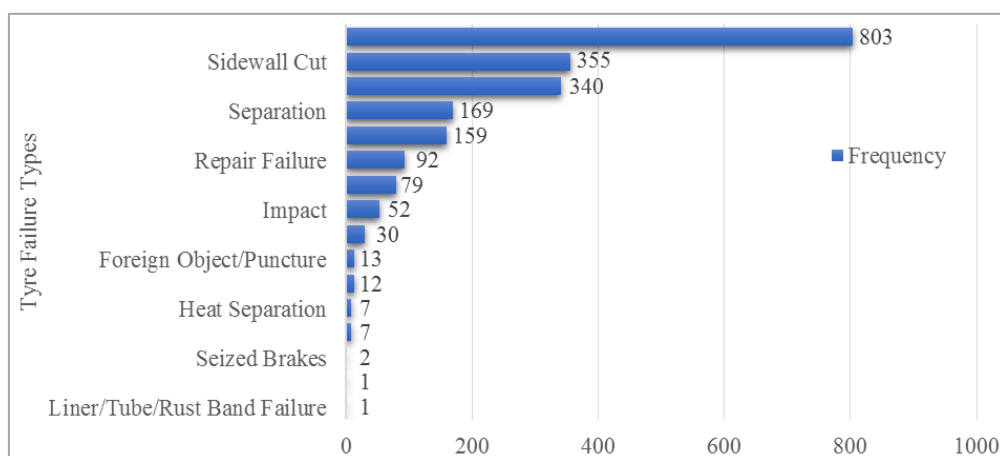
Figure 4. Tyre Failure Mode.

From Figure 4, the premature tyre failures were further grouped into five to undertake qualitative research through field surveys/tours, haul truck tyre observations, and interviews with junior staff, supervisors, general foremen, and superintendents from both mine operations unit and maintenance department. This research is to aid in identifying the major causes of each of the premature tyre failure modes, which have been summarised and presented in Figure 5.

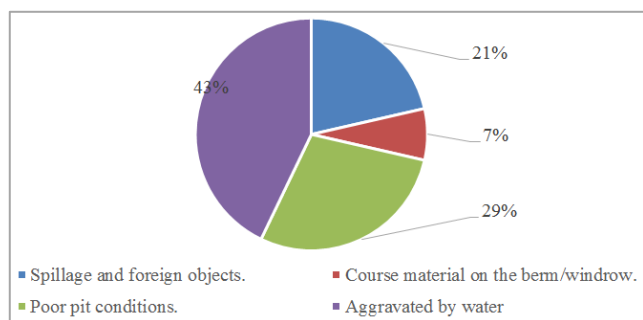
**Figure 9.** Causes of Haul Truck Tyre Shoulder Cut.

In interviews with field workers, supervisors and superintendents from the mine operation and tyre maintenance departments, the following were identified as contributing factors: Spillage and foreign objects; Course material on the berm/windrow; Poor pit conditions; and aggravated by water. Following the identified causes of shoulder cuts, a field study was conducted in the Subika and Awonsu pits of NAM, Ghana. The data collected recorded 8 cases over the period of 12 months. The breakdown is presented in Figure 9. It was clear that the major causes of premature tyre failure by shoulder cut are aggravations by water and poor pit conditions. Figure 8 below shows a cut in the shoulder area but no casing damage.

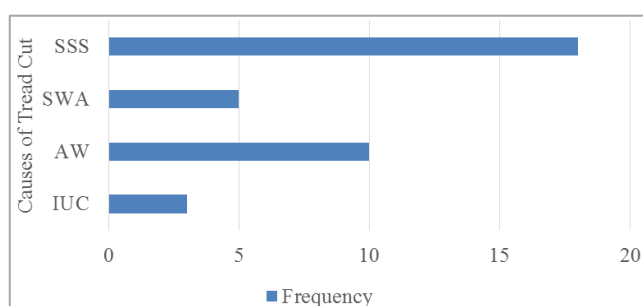
**Figure 11.** Category of the Major Causes of Haul Truck Tyre Tread Cut.

A typical example of a cut in the tread crown but not penetrating the casing is presented in [Figure 10](#). The causative factors of the tread cut include Improper inflation or underfoot conditions (IUC); Aggravated by water (AW); Sharp objects in the work area (SWA); and spinning, skidding or sliding (SSS). The number of cases recorded for the factors that cause tread cut was taken and analysed in [Figure 11](#).

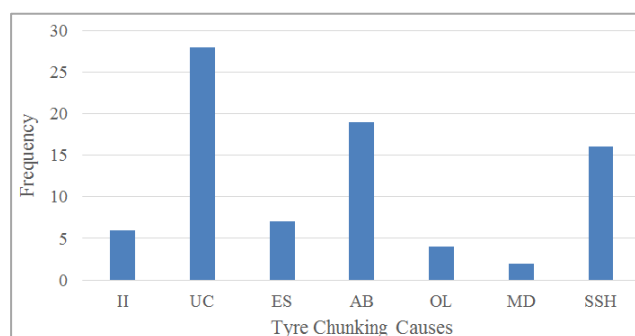
**Figure 13.** Causes of Tread Chunking of Haul Truck Tyres at NAM, Ghana.

Chunking refers to the phenomenon of missing tyre tread sections, as depicted in [Figure 12](#). It appears the tread has been removed in pieces or ripped away from arbitrary locations on the tyre. In interviews with relevant workforces, contributing factors revealed the following: Improper infla-

tion (II); Underfoot conditions (UC); Excessive speeding (ES); Aggressive braking (AB); Overloading (OL); Mismatched diameters on dual tyre machines (MD); and spinning, skidding or high torque (SSH). Data collected over a period of 12 months, from January 2020 to December 2020, on Haul truck tyre premature failure resulting from tread chunking has been analysed and presented in [Figure 13](#).

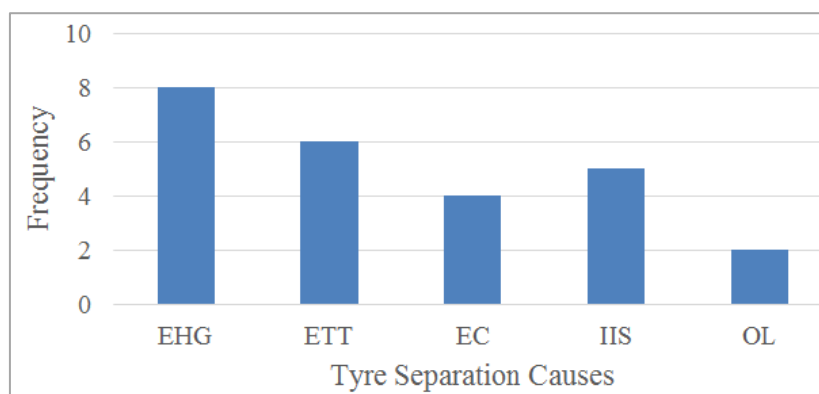
**Figure 15.** Causes of Haul Truck Tyre Separation.

Tyre tread separation is a dangerous condition wherein the tyre's tread separates itself from the casing or body of the tyre. Thus, it is the deformation of the tread area due to the tread band separating from the casing ply, as shown in [Figure 14](#). The contributing factors are excessive heat generation (EHG), exceeding the TKPH for the tyres (ETT), excessive cornering (EC), incorrect inflation or speed (IIS), and overloading (OL). Having identified the major causes of the haul truck tyre failure by separation, fieldwork was done over 12 months – January 2020 to December 2020, to obtain data regarding the most applicable causes of tyre separation at NAM, Ghana. The result obtained has been summarised in [Figure 15](#).

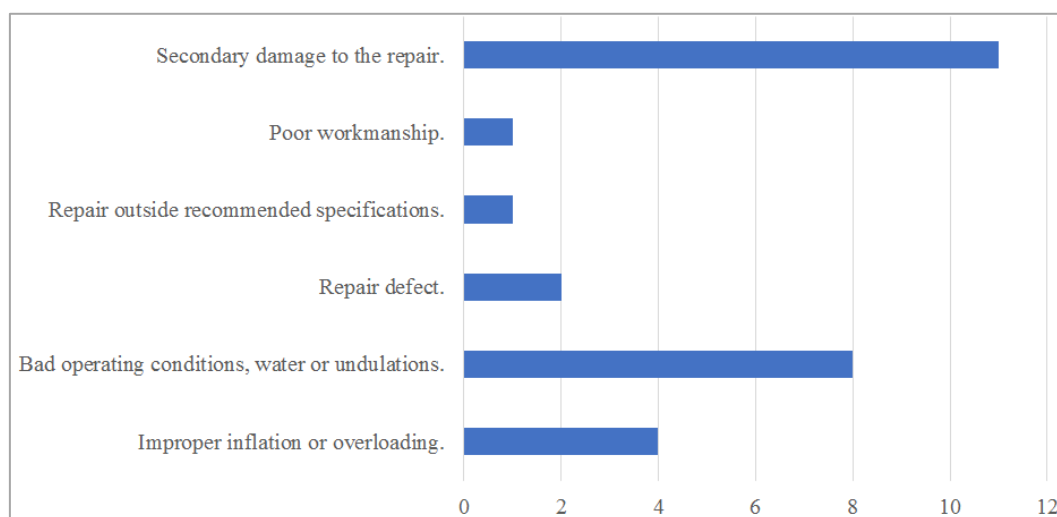
**Figure 17.** Major Causes of Tyre Worn at NAM.

According to the tyre damage report acquired from the maintenance department, factors contributing to the wear of haul truck tyres include i) improper inflation or overloading, ii) unfavourable operating conditions such as water or undulations, iii) defects in repairs, iv) repairs conducted outside recommended specifications, v) subpar workmanship, and vi)

secondary damage caused by the repair process. A field study on the causes of haul truck tyres worn out at NAM, Ghana, was carried out by recording the various factors that contributed to tyre worn out from January 2020 to December 2020. The result is presented in Figure 17.

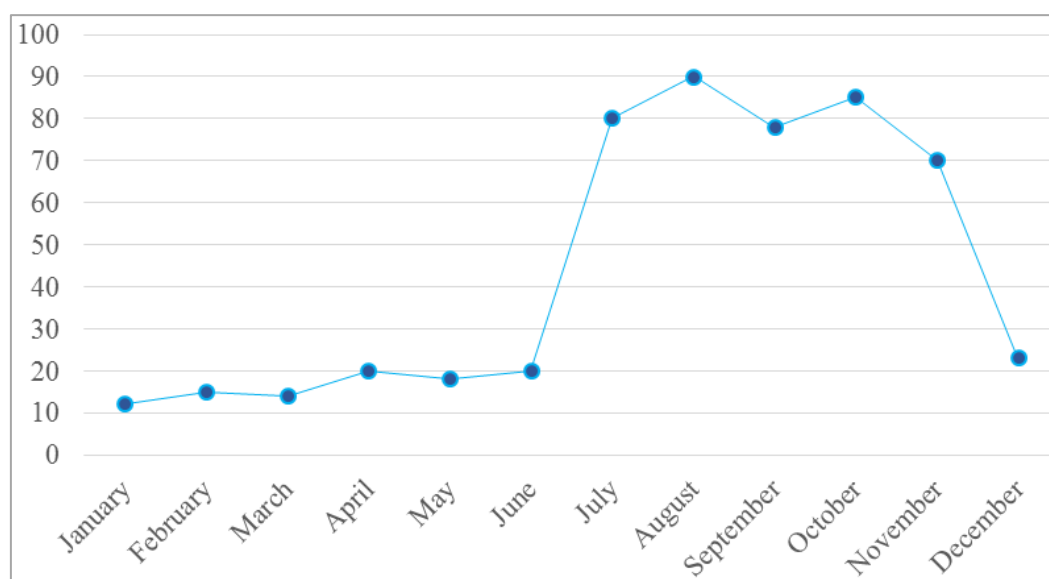
**Figure 18.** Premature Tyre Failure Trend in NAM, Ghana.

During the data collection and observation, it was noticed that more cases were recorded in certain months. This necessitated tallying the total tyre failures recorded for each month during the study to identify any hidden trend in premature tyre failures within the year. The study was conducted from January 2020 to December 2020. The summary is presented in [Figure 18](#).

With the Ahafo region being part of the forest belt of Ghana, it records its wet season from July to November, while the dry season starts from December to April. The trend indicates that most of the premature tyre failures were recorded during the wet seasons as compared to the dry seasons.
