Research/Technical Note

A Useful Technique for Removing a Broken Guide-wire in the Femoral Neck Through the Proximal Femoral Nail Hole During Operation

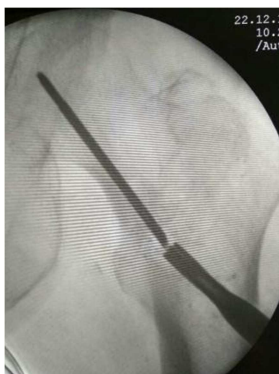
Figure 1. Broken pin in a 71-year-old patient at the time of reaming.

intertrochanteric fracture was performed under a C-arm X-ray Machine. The surgeon performed a standard skin incision about 5 cm proximal from the tip of the greater trochanter and exposed. Then, the entry point was made. The guide wire was passed through and reaming of the canal by the rod. After reaming, assemble PFNA instruments, a proximal femoral nail with appropriate size and diameter was inserted easily. Choose aiming arm for PFNA blade insertion and prepare guide-wire insertion, position guide-wire with aiming device and insert it. However, when the cannulated reamer through the neck to the head of the femur, a sudden loss of resistance was unexpectedly encountered. On checking under a C-arm image intensifier showed that the guide-wire was broken about 5 cm from the threaded end. In one case the broken guide-wire had not breached the hip joint, just touching the articular surface of the femoral head. In the other case the broken guide-wire was just protrusion into the hip joint. The surgeon therefore decided to remove it.

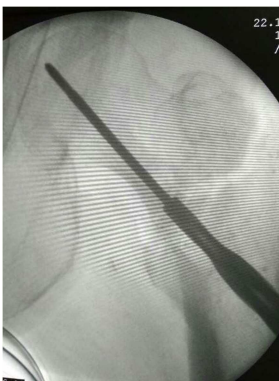
Figure 2. Confirm the cannulated reamer to sight the broken end of the wire.

We tried to use the Kocher forceps and Kerrison/pituitary rongeur to remove the broken pin. The both above method for removing the broken guide-wire were failed. Ultimately, we used the original cannulated reamer to ream over the guide wire under the C-arm image intensifier. At first, confirm the cannulated reamer to sight the broken end of the wire, and passed through the broken guide-wire in both image planes. Then, the reamer was advanced further reaming with low speed rotation till the beginning of the reamer encased the broken guide-wire. Afterwards, the reamer was withdrawn a few millimeters, compared anteroposterior and lateral view with all the previous images to confirm dislodgment of the guide-wire from its original position. After confirmation of the broken guide-wire dislodgment and firmly engaged within the drill lumen. Reverse the guide-wire slightly with the reamer from the bone. C-arm image intensifier confirmed complete removal of the guide-wire fragment. The PFNA blade was inserted in its original track and distal locking to complete the procedure. The screw purchase was found to be satisfactory.

The operator only needs to continue the original operation procedures. Put the original cannulated reamer into the screw hole, confirm the reamer to sight the broken end of the wire, and pass through the broken guide-wire under a C-arm image intensifier in both anteroposterior and lateral views. Because the cross-sectional shape of the pin changes to an oval rather than a round shape at the point of the break, reaming with a cannulated reamer engages the pin, allowing the pin to be removed easily [14]. Generally speaking, once the threads were engaged the broken piece of wire was easily removed by withdrawing the reamer. After our experience with the first patient, in the other 2 cases we used an original cannulated reamer to avoid any extensive reaming and trauma to the tissues. With this method, we were able to remove the broken pin easily in a few minutes.

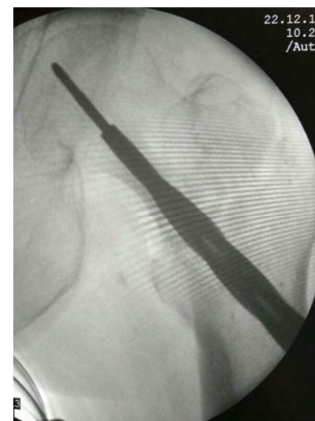
Figure 3. The reamer was passed through the broken guide-wire under the C-arm image intensifier.

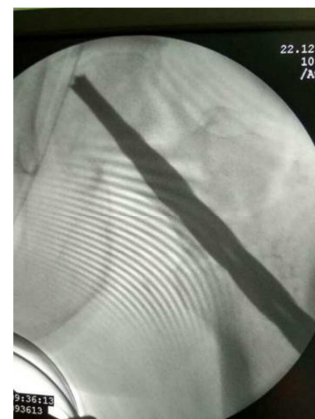
Figure 4. The reamer was advanced further reaming till its encased a large portion of the broken guide-wire. Afterwards, reverse the guide-wire with the reamer from the bone.

The idea came out during our ordinary practice, sometimes the guide-wire may along with the reamer when withdraw the cannulated reamer. The guide-wire sometimes trapped, together with bone debris, within the lumen of the cannulated reamer. This was perhaps the reason why we could use the cannulated reamer to retrieve the broken guide-wire, and it also can use a cannulated drill bit to retrieve the broken guide-wire.

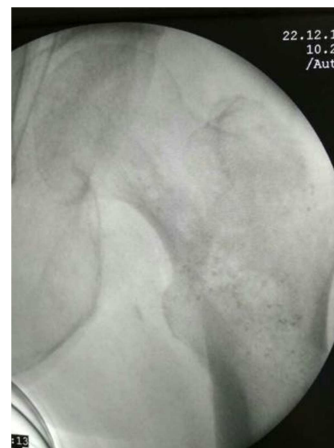
Figure 5. The broken pin is complete removed by a cannulated instrument.

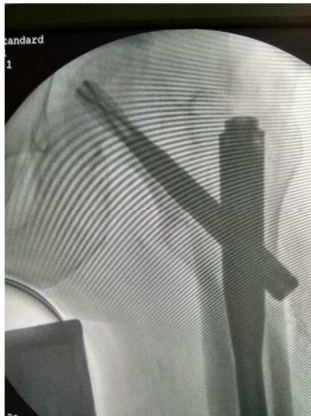
Figure 6. The PFNA blade was inserted in its original track to complete the procedure.
